IMC Potash Esterhazy – K2 Division Pre-placed Aggregate Repair System

STRUCTURE: Headframe Building
LOCATION: K2 Minesite, Esterhazy, SK
PROJECT DATE: 1999
JOB DURATION: 2 Months
CLIENT CONTACT: Terry Heal
AREA: Structural Support Beams
CONTRACTOR: Vector Construction Ltd.
Saskatchewan Branch

#3-99SK_IMC

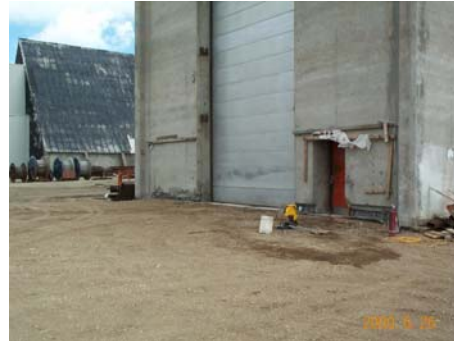
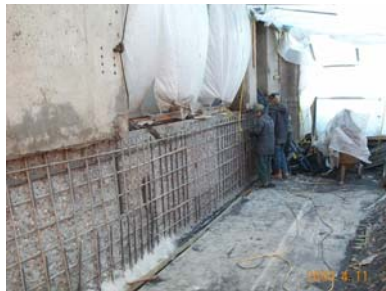
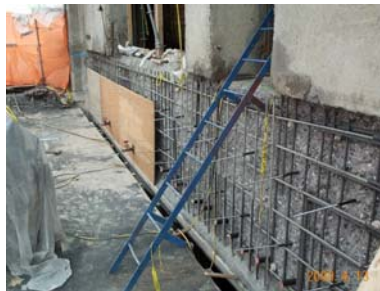
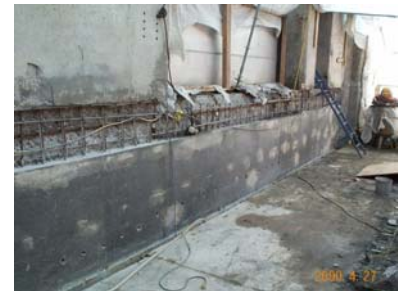
Problem: Salt induced corrosion causing deterioration of structural supporting beams.

Area: Two structural support beams across the west face of the headframe building at ground elevation and one level below ground elevation.

- Remove deteriorated concrete and corroded reinforcing steel.
- Grit blast remaining reinforcing steel.
- Install new reinforcing steel as required to match original.
- Install Galvanic Anodes to inhibit further corrosion.
- Form to original dimension.
- Fill the form with ¾" to 1 ¼" washed rock.
- Pump the form full of EMACO 77CI high flow repair mortar.
