Cogema Resources – McClean Lake Sumps – Sikadur EPC

STRUCTURE: Sump Repairs
 LOCATION: Cogema McClean Lake Uranium Mine
 PROJECT DATE: Summer 2001, Winter 2001, Winter 2002
 JOB DURATION: 3 – 10 day Shutdowns
 CLIENT CONTACT: Brian Doell
 AREA: 8 Sumps – 4' x 4' x 4'
 CONTRACTOR: Vector Construction Ltd.
 Saskatchewan Branch

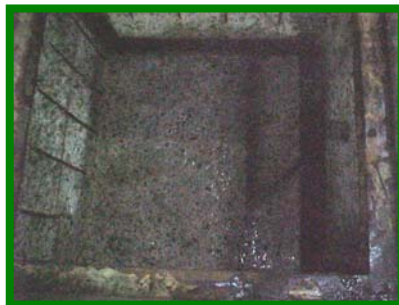
Deteriorated Sump

Function of the Sumps: Collection of operations chemical spills and wash-down water.
 Problem: Chemical attack of the concrete and chemical caused corrosion of the reinforcing steel.
 Area Repaired: As above lined with 1 ½” minimum of Sikadur EPC Mortar.
 Procedure:

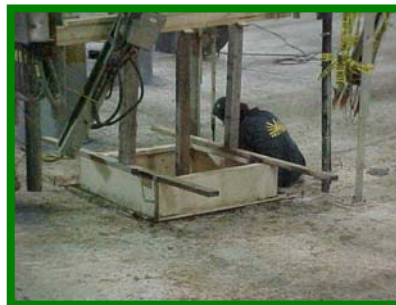
Forming Repair System

- Remove deteriorated concrete.
- Clean reinforcing steel.
- Form as required to 1 ½” overbuild of original dimension.
- Mix and pour Sikadur EPC as per manufacturer's recommended procedures.
- Allow a minimum of 24 hour cure prior to stripping the form.

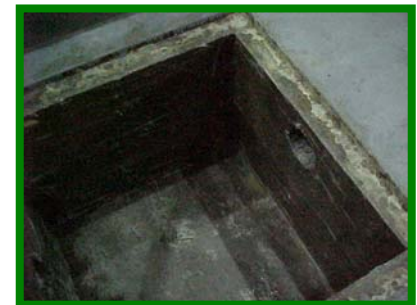
Sikadur EPC Repair Completed
