INNOVATIVE  
REPAIRS  
PRESERVE  
40-YEAR OLD  
COOLING TOWER

**COAL CREEK POWER STATION:**  
UNDERWOOD, ND

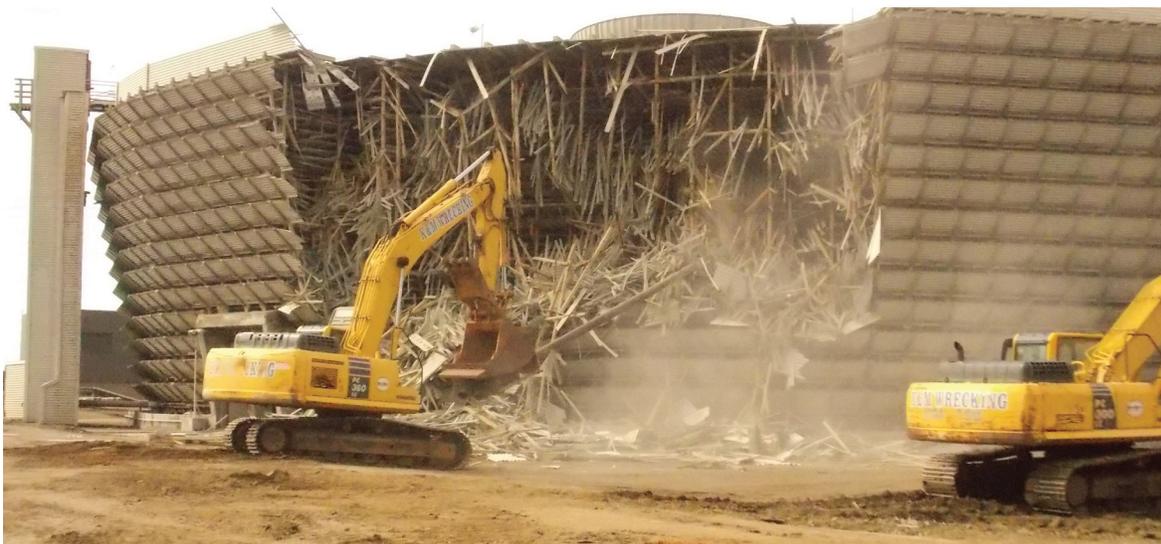
*Fig.1: Demolition of the outer structure of the cooling tower to expose the interior concrete structure.*

1. Demolition of the exterior structure (Fig. 1) which was originally built with pressure treated lumber framing and sheet metal, thus exposing the interior concrete structure.
2. Concrete rehabilitation work including structural concrete repair, crack repair, waterproofing, beam replacement, and protective coatings.
3. Installing the new field-erected FRP exterior structure connected to the rehabilitated concrete frame.

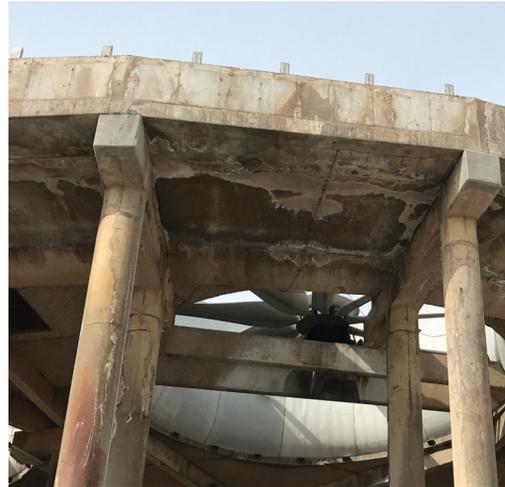
The structure's age, years of constant heavy use, leaking water through joints (Fig. 2) in the precast concrete hot water basin and freeze thaw cycling were the primary sources of the concrete deterioration as evidenced by rust staining, cracking, spalling, concrete delaminations and general wear. The North Dakota environment is rather extreme with a 181 °F variation between its highest and lowest recorded temperatures, the 3rd largest variation of any U.S. State.

*Fig. 2: Leaking joints in precast concrete hot water basin led to deterioration throughout the concrete structure.*

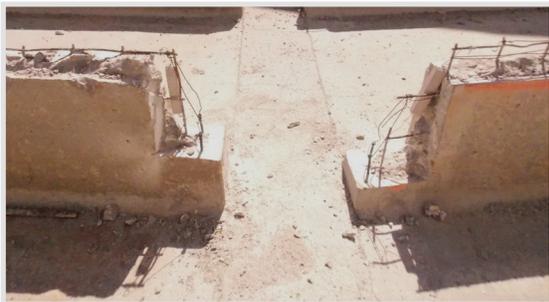
The primary deterioration in the floor was the vertical fins. Deteriorated and freeze-thaw damaged concrete was removed and additional steel, anchors and galvanic anodes were installed to protect the corroding fins (Fig. 3). After temporary formwork was installed, the concrete was replaced with a high early strength / high performance concrete consisting of microsilica, fly ash, water reducer, air entrainment and a 0.45 water:cement ratio that was custom designed for the application. High range water reducers were added to achieve the desired slump for workability.

*Fig. 3: Prepared precast fins with Type 1A galvanic anodes awaiting new high performance concrete.*

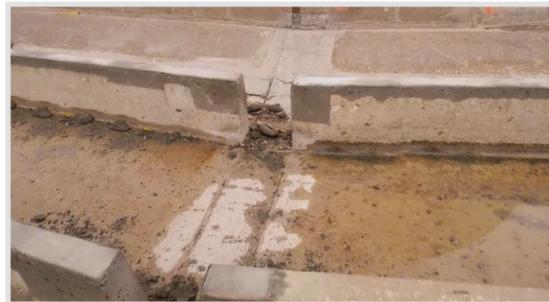
*Fig. 4: Concrete fins repaired, prior to protective coating application.*

The ready mix repair material placed into a concrete bucket and lifted by crane to the hot water basin where it was wheel barrowed to the fins to complete the form and pour concrete repairs (Fig. 4). To protect the fins, a 100% solids hybrid novolac protective coating was applied at an approximate 15 mils dry film thickness. The selected protective coating exhibits excellent water immersion resistance after only 3 days of curing.

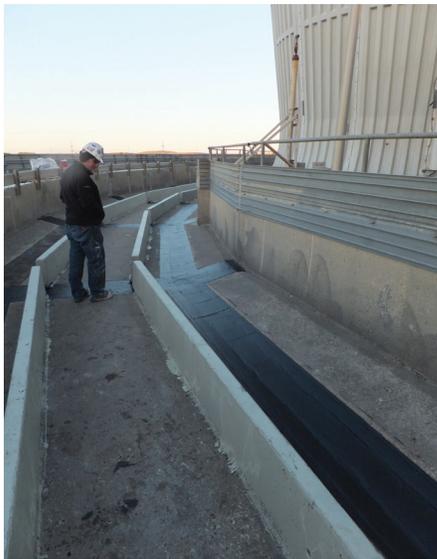
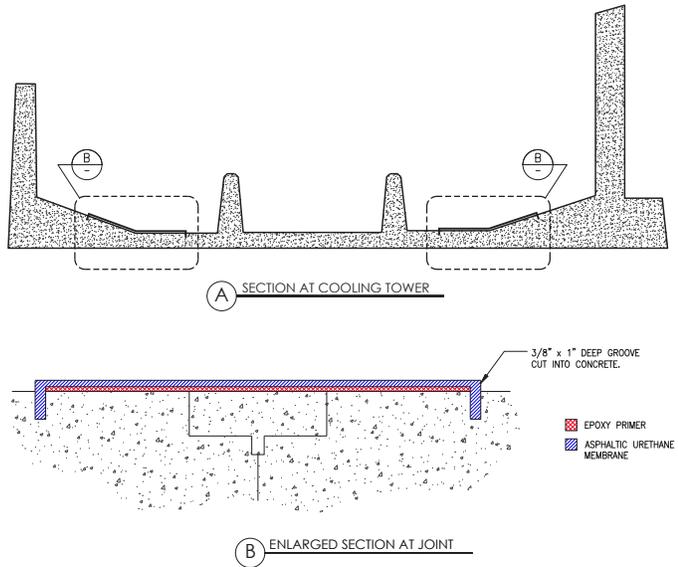
*Fig. 5: Completed hot water basin floor repairs including concrete repairs and waterproofing.*

Construction joints between the precast floor and wall sections, a source of unwanted water leakage onto the lower columns and beams, were waterproofed with an elastomeric urethane asphalt membrane system for concrete. First, 3/8” wide by 1” deep grooves parallel to the joints were sawcut about 4” on both sides. After the concrete surface was sandblasted, an epoxy primer was placed. Finally the chemically cured urethane asphalt membrane was placed across the epoxy primer and anchored into the sawcut grooves (Fig. 5). The system is designed to remain elastic to temperatures as low as -40°F (-40°C) with very good physical abrasion resistance.

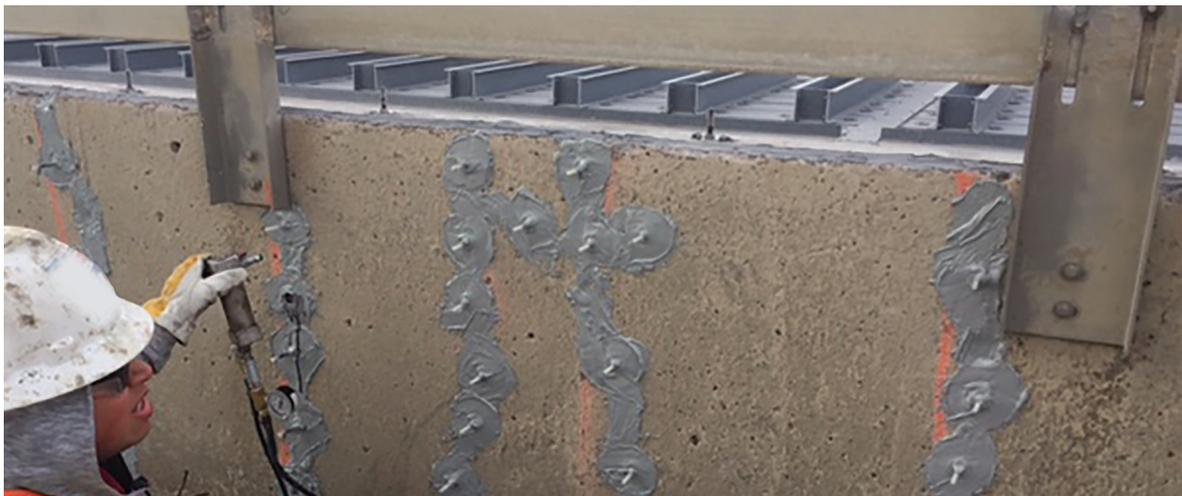
*Fig. 6: Epoxy adhesive injected to seal fine cracks in the basin walls.*

Basin wall cracks were repaired using the epoxy injection process (Fig. 6). Plastic injection ports and epoxy paste seals were placed over cracks as thin as 4 mils in width and filled under pressure using purpose-built plural component pumps capable of maintaining the proper mix ratio under pressure. The injection port spacing was relatively narrow to promote adequate filling of the fine cracks.

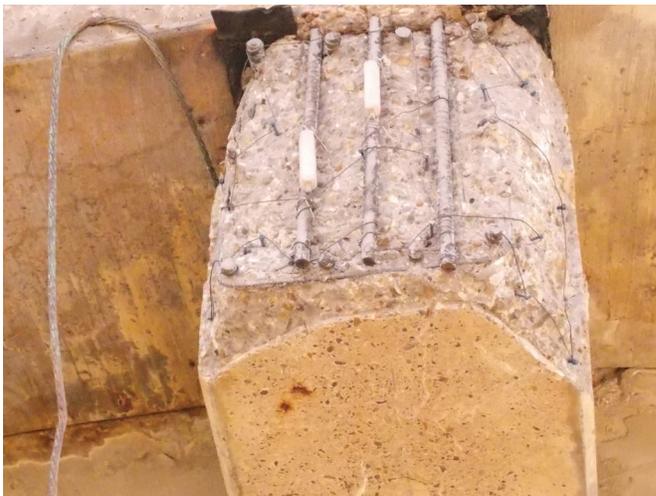
Leaking water from the hot water basin had contributed to the deterioration of the substructure. Deteriorated beam ends and columns were repaired with the same high performance ready mix concrete as used for the precast fin repairs. Preparation of the cast-in-place beam ends followed procedures as outlined in ICRI Technical Guidelines such as 310.1R-2008 - Surface Preparation for the Repair of Deteriorated Concrete. The concrete repairs also include Type 1A embedded galvanic anodes for enhanced long term durability (Fig. 7). For the column repairs, only spalled and delaminated concrete cover was removed to save time and to mitigate the need for structure shoring which would impact the budget and schedule (Fig. 8). To improve durability of the column repairs, additional anchors were installed into the repair areas such that the repairs would have both chemical and mechanical bond.

*Fig. 7: Deteriorated beam end with concrete removed and Type 1A embedded galvanic anodes installed.*

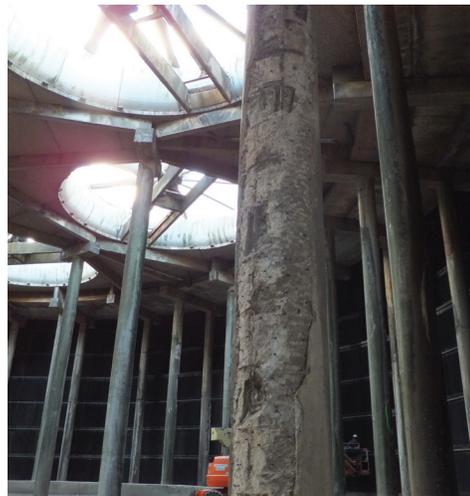
*Fig. 8: Example of damaged column under the hot water basin, prior to concrete repair.*

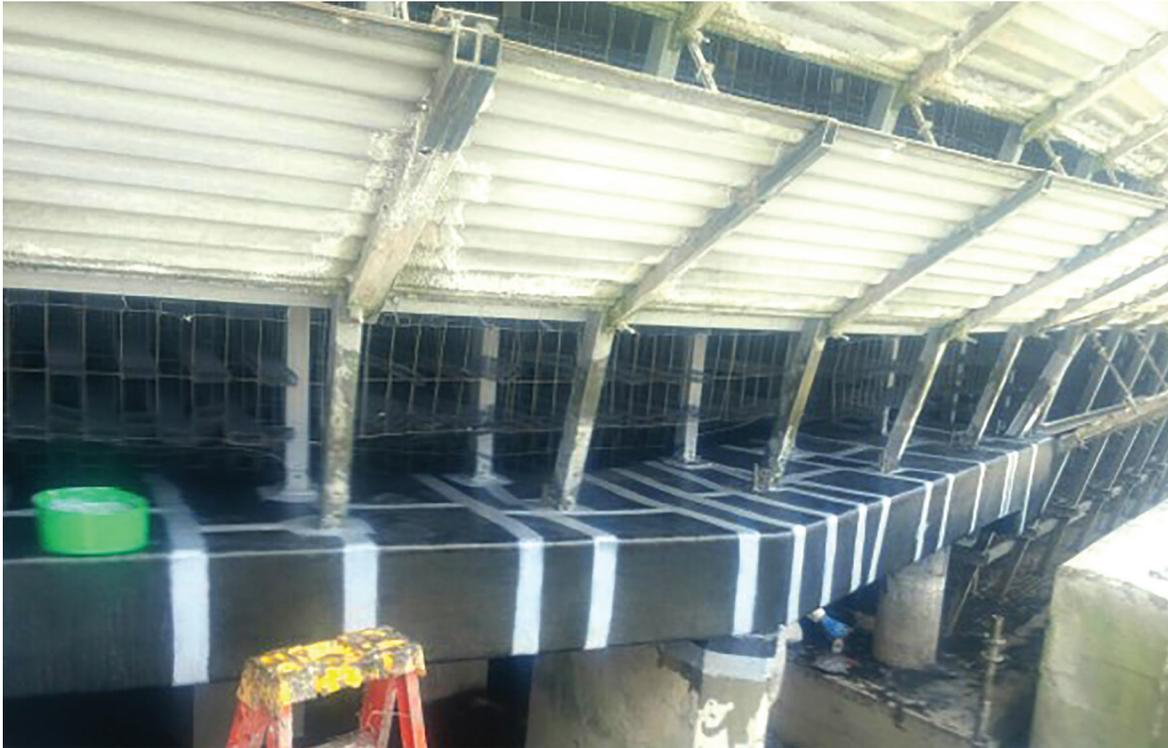
As previously mentioned, Cooling Tower #91 is one of three. When repairing the adjacent cooling towers, the precast beams that support the outer wood/sheet metal structure were repaired then strengthened using surface bonded carbon fiber (Fig. 9).

*Fig. 9: Previously repaired beams strengthened with CFRP.*

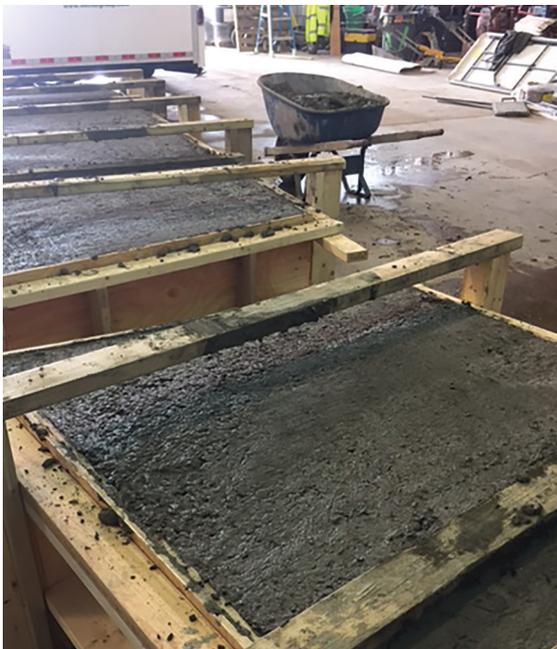
*Fig. 10: Precast concrete beams were cast in temporary beds inside the contractor's shop.*

In preparation of the shutdown, new precast concrete replacement beams were constructed in the contractor's shop months before they were taken to site (Fig. 10). The beams were constructed with a high performance ready mix concrete and shop-fabricated stainless steel connection plates were used for added long term durability. The new replacement beam was precast in two sections to facilitate easy of handling. The controlled environment of the shop provided excellent curing conditions for the new beams. The existing beam was wire cut, removed and replaced with the new beam (Fig. 11).

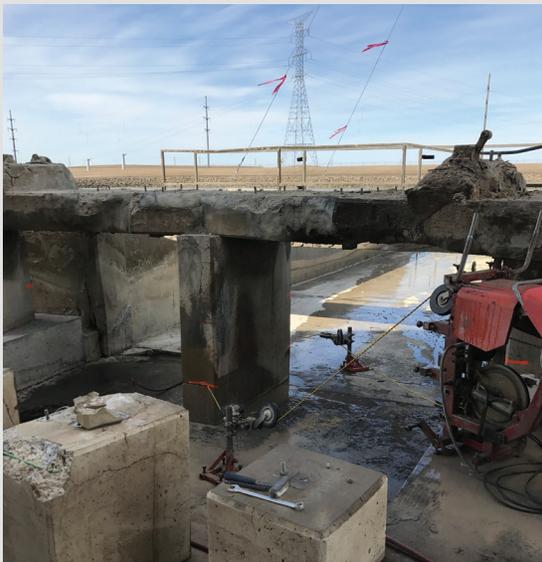
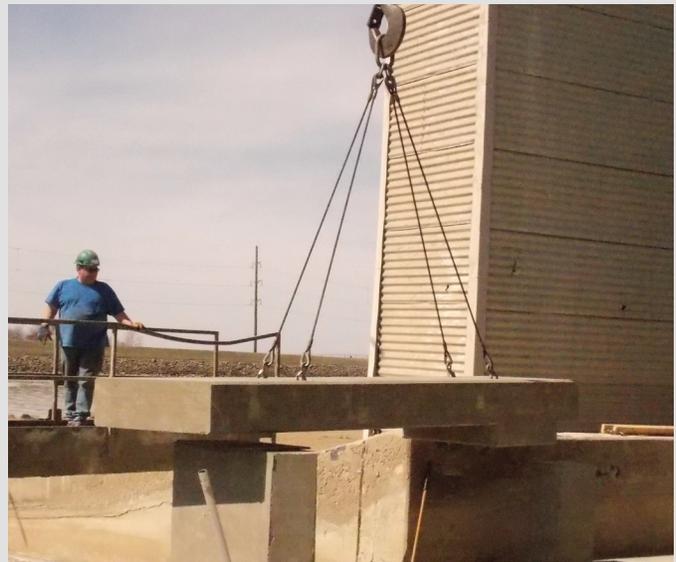
The same strengthening technology was expected to be used on Tower #91 however advanced deterioration was discovered during the fall inspection. Based on this new information, it was decided to completely replace the severely deteriorated precast beam that spanned the outlet flume. Based on the relatively short shutdown schedule, utilizing precast concrete was deemed to be the most effective approach to replace the roughly 24'x4'x1.5' beam.

*Fig. 11: Severely deteriorated beam was wire cut, removed and replaced with new freeze-thaw resistant precast beams.*

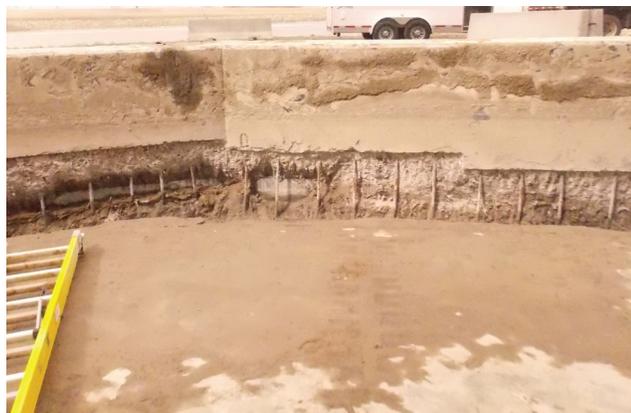
*Fig. 12: Concrete repairs at the wall-to-floor cold joint in the cold water basin.*

In addition to the beam replacement, major concrete repairs were required at the wall-to-floor joint in the cold water basin. The concrete repairs were also completed according to ICRI guidelines with the same high performance ready mix concrete mix.

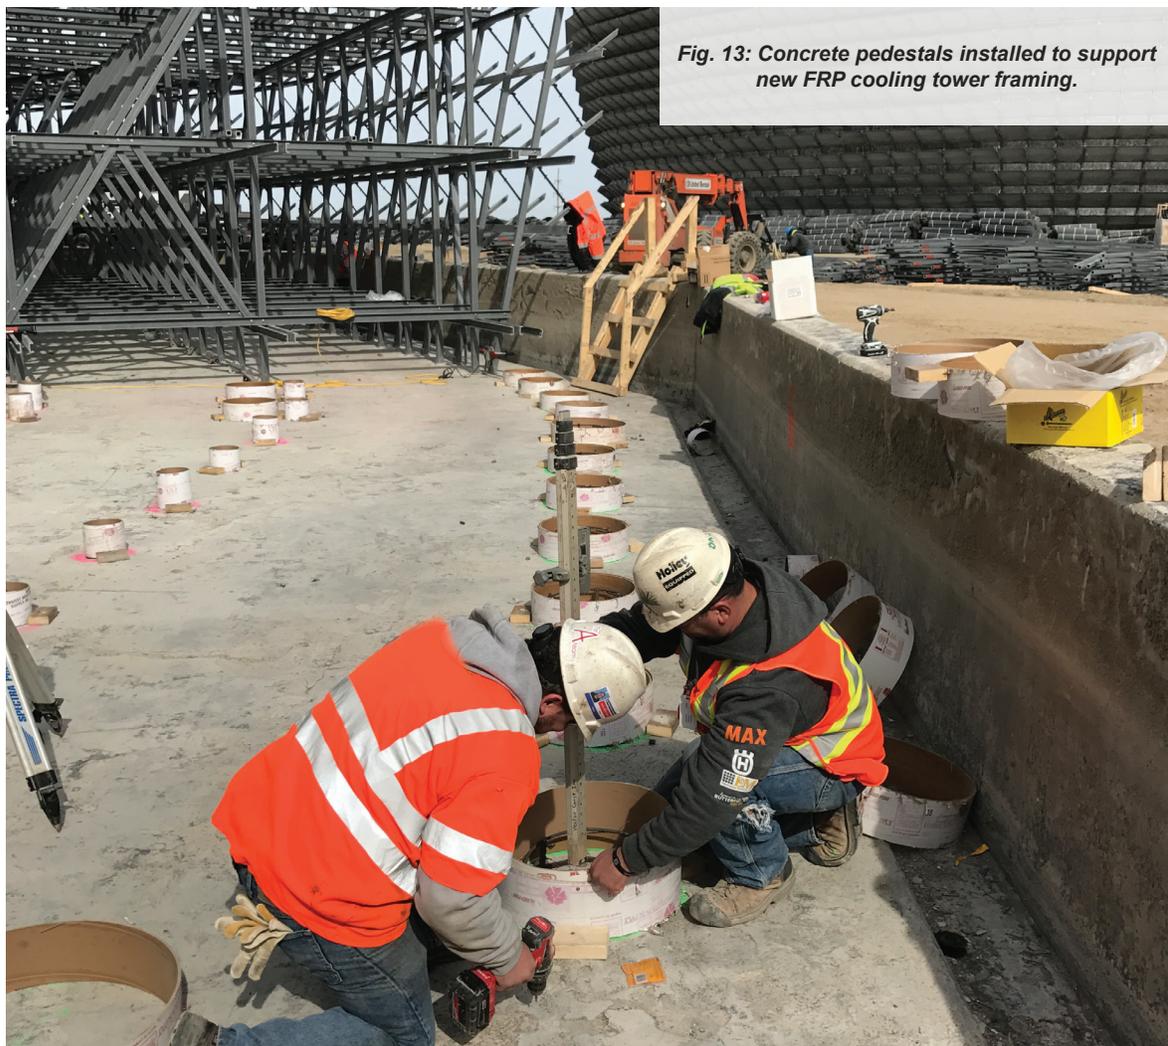
**Fig. 13: Concrete pedestals installed to support new FRP cooling tower framing.**

Finally, in the cold water basin, new reinforced concrete pedestals were installed into the floor to support the new FRP framing. According to the design, the round pedestals were to be of various diameters and heights. As part of the project planning process, innovative adjustable formwork was devised using multiple rings of engineered concrete fiber forms to allow the proper pedestal elevation to be efficiently achieved in the field.
