Strengthening of Grinding Building Slab

Batu Hijau Copper-Gold Mine

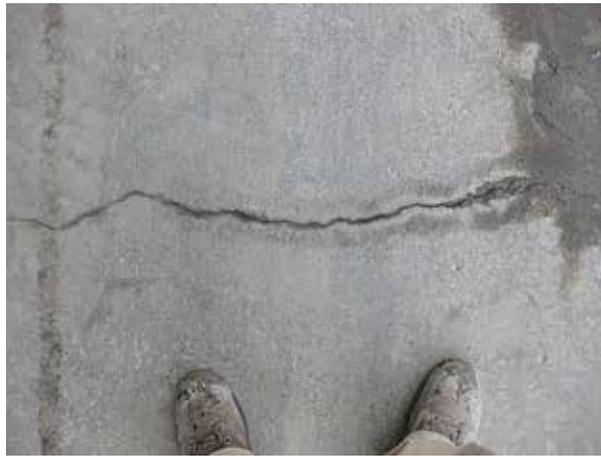
The condition of the 14 year old slab clearly showed signs of a lack of tensile reinforcing whereby large structural cracks could be seen over the top of many of the steel support beams. However, prior to designing the repair, a field investigation was completed to confirm the existing condition of the slab.

Typical Negative Moment Crack Over Beams

The strength reduction was confirmed through a structural analysis comparing the factored loads felt by the slab to its factored strength. The two main problems were that there was insufficient positive moment reinforcing provided, and there was no negative moment reinforcing called for in the design.

The proposed repair procedure would be to epoxy inject the cracks and upgrade the slab using advanced composites.

Pressurized epoxy injection is a method which fills voids in cracked concrete by providing a medium stronger than the concrete where it has become weakened by a crack. In the case of a negative moment crack located on top of a support, repairing such cracks becomes particularly important due to the felt shear stresses in this region, which under a uniform load are higher than any other location along the structural member.

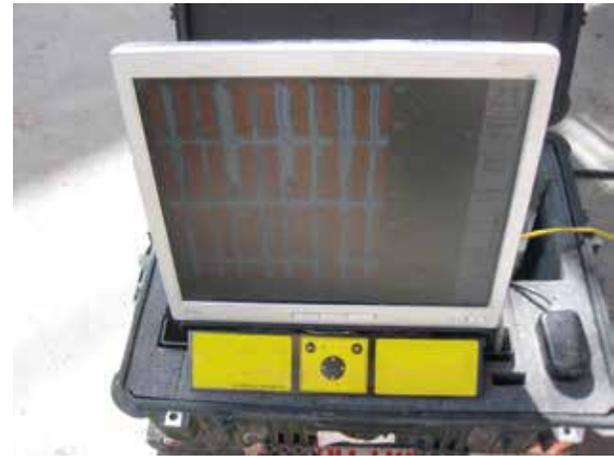
A ground penetrating radar survey revealed that the reinforcing bars intended to restrain shrinkage were installed in the structural direction and vice versa. This resulted in only 33% of the specified reinforcing being installed in the structural direction leading to a significant strength reduction versus the original design.

Ground Penetrating Radar (GPR) Survey

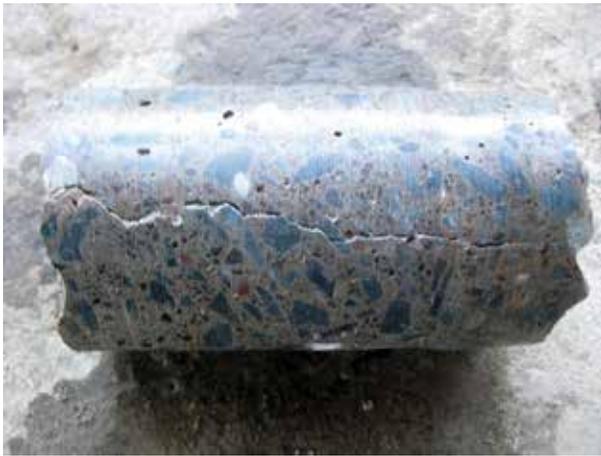
Several cores were taken in cracked areas and revealed that most of the cracks extended the full depth of the concrete slab and could be broken in two by hand.

Core Sample Showing Full-depth Cracking

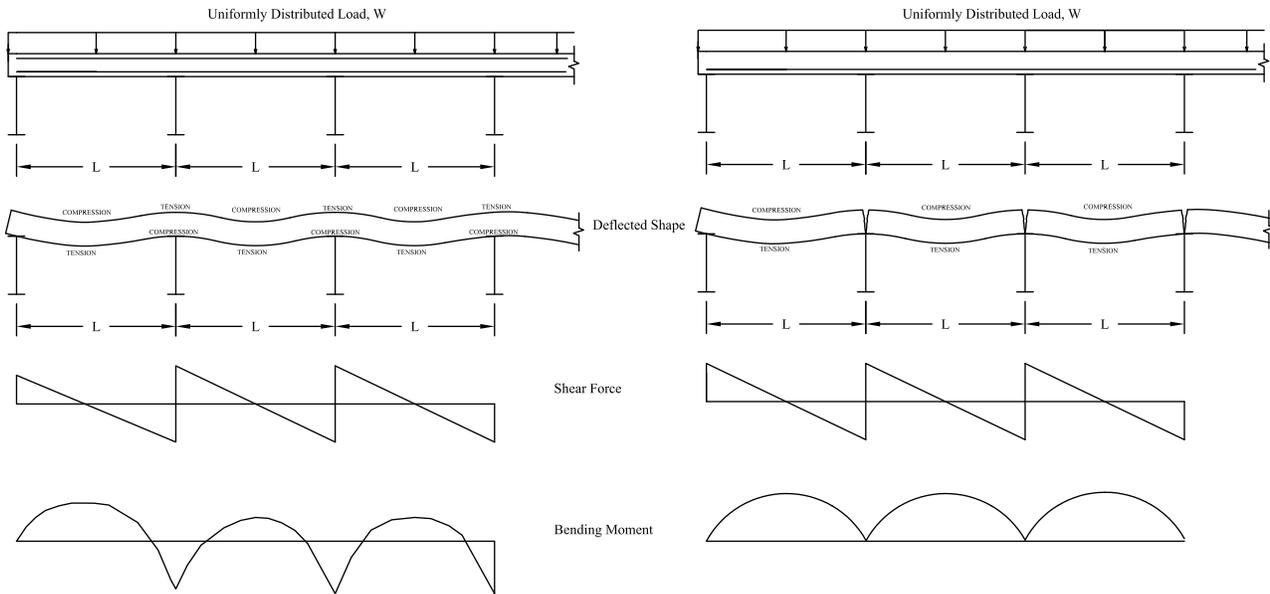
Qualitative BMD, SFD for Continuous Slab (LHS) and Adjacent Simple Spans (RHS)

The approximate bending moment and shear force diagrams (Figure 4) show the difference between a slab or beam reinforced for positive and negative bending moments (post-repair condition), compared to a slab or beam reinforced only for positive moment (pre-existing condition). The result is a reduction in positive moment on account of negative moment resistance being provided.

By enabling the slab to carry negative moment over the supports, the positive moment on the midspan sections identified to be insufficiently reinforced could be reduced to a magnitude which was calculated to be within acceptable limits for the as-built reinforcing condition.

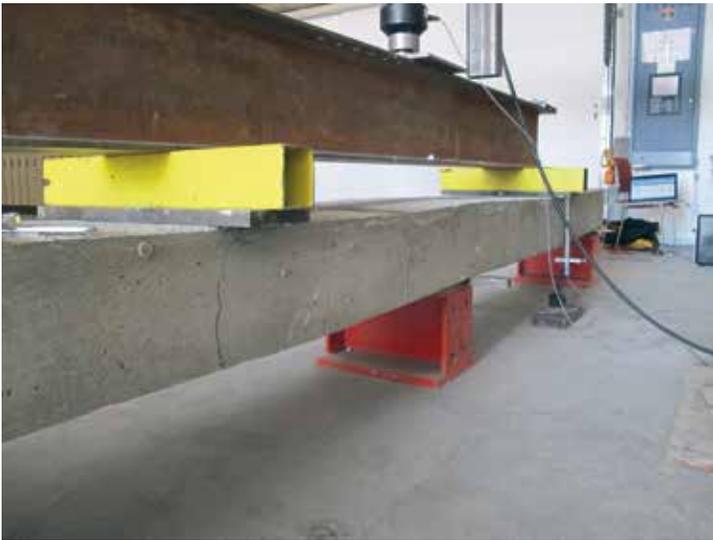
Slab Modelled after Existing Condition

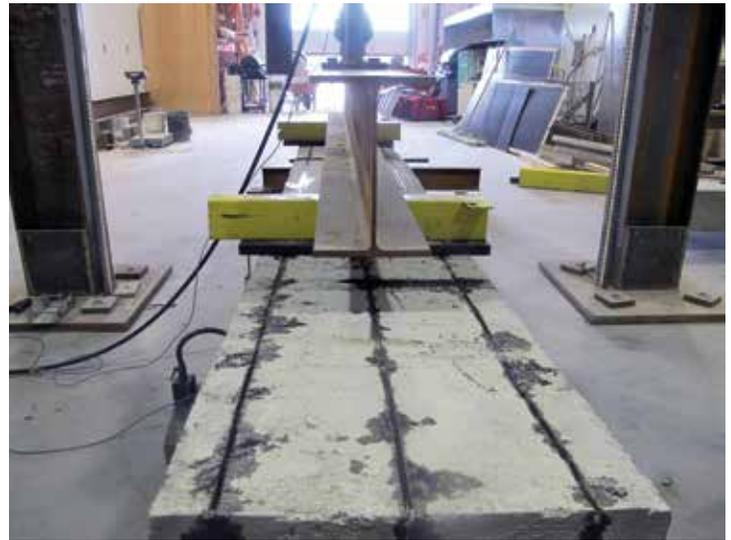
Slab Modelled after Strengthened Condition

The results of the tests indicated that this method was highly effective in providing the additional negative moment resistance to allow the slab to carry the original design live loads. On average, the repair method provided a 57% increase in overall failure load, which was caused by overall shear failure of the concrete.

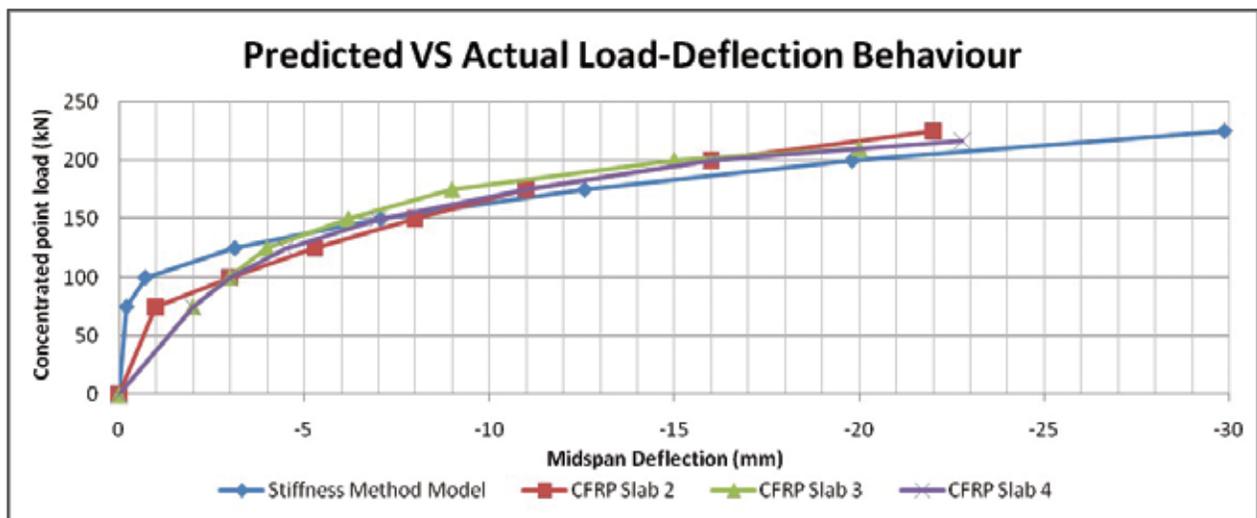
An advanced calculation model was used which resulted in a predicted load vs displacement relationship. Basic assumptions were used involving strain compatibility and a perfect bond between the CFRP and the concrete. The predicted load vs displacement behaviour very closely matched the actual behaviour of the specimens, and on that basis, back calculating from the model, the strain at which the CFRP debonded was determined and the design strain used in the section strength calculations was confirmed to be appropriate and included a sufficient factor of safety.

Predicted vs Actual Load-Deflection Results

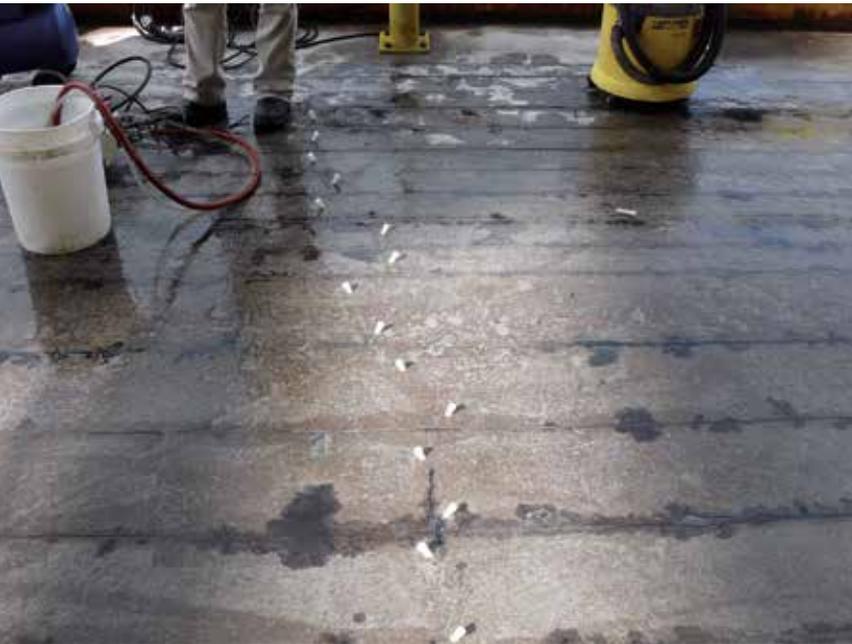
The epoxy injection repairs were more difficult at this project than usual, mainly due to mineralization of process water blocking the cracks and preventing epoxy from flowing from one port to the next.

- Install injection ports intersecting the cracks at approximately 45 degrees
- Seal the top surface of the cracks with appropriate epoxy adhesive
- Inject under high pressure a diluted phosphoric acid solution to clean the crack of any mineralization or other blockages
- Inject clean water under high pressure to remove any remaining phosphoric acid or residue from the cracks
- Inject the cracks using appropriate epoxy resin
- Confirm proper crack penetration through core sampling

Ports Installed for Cleaning / Injection

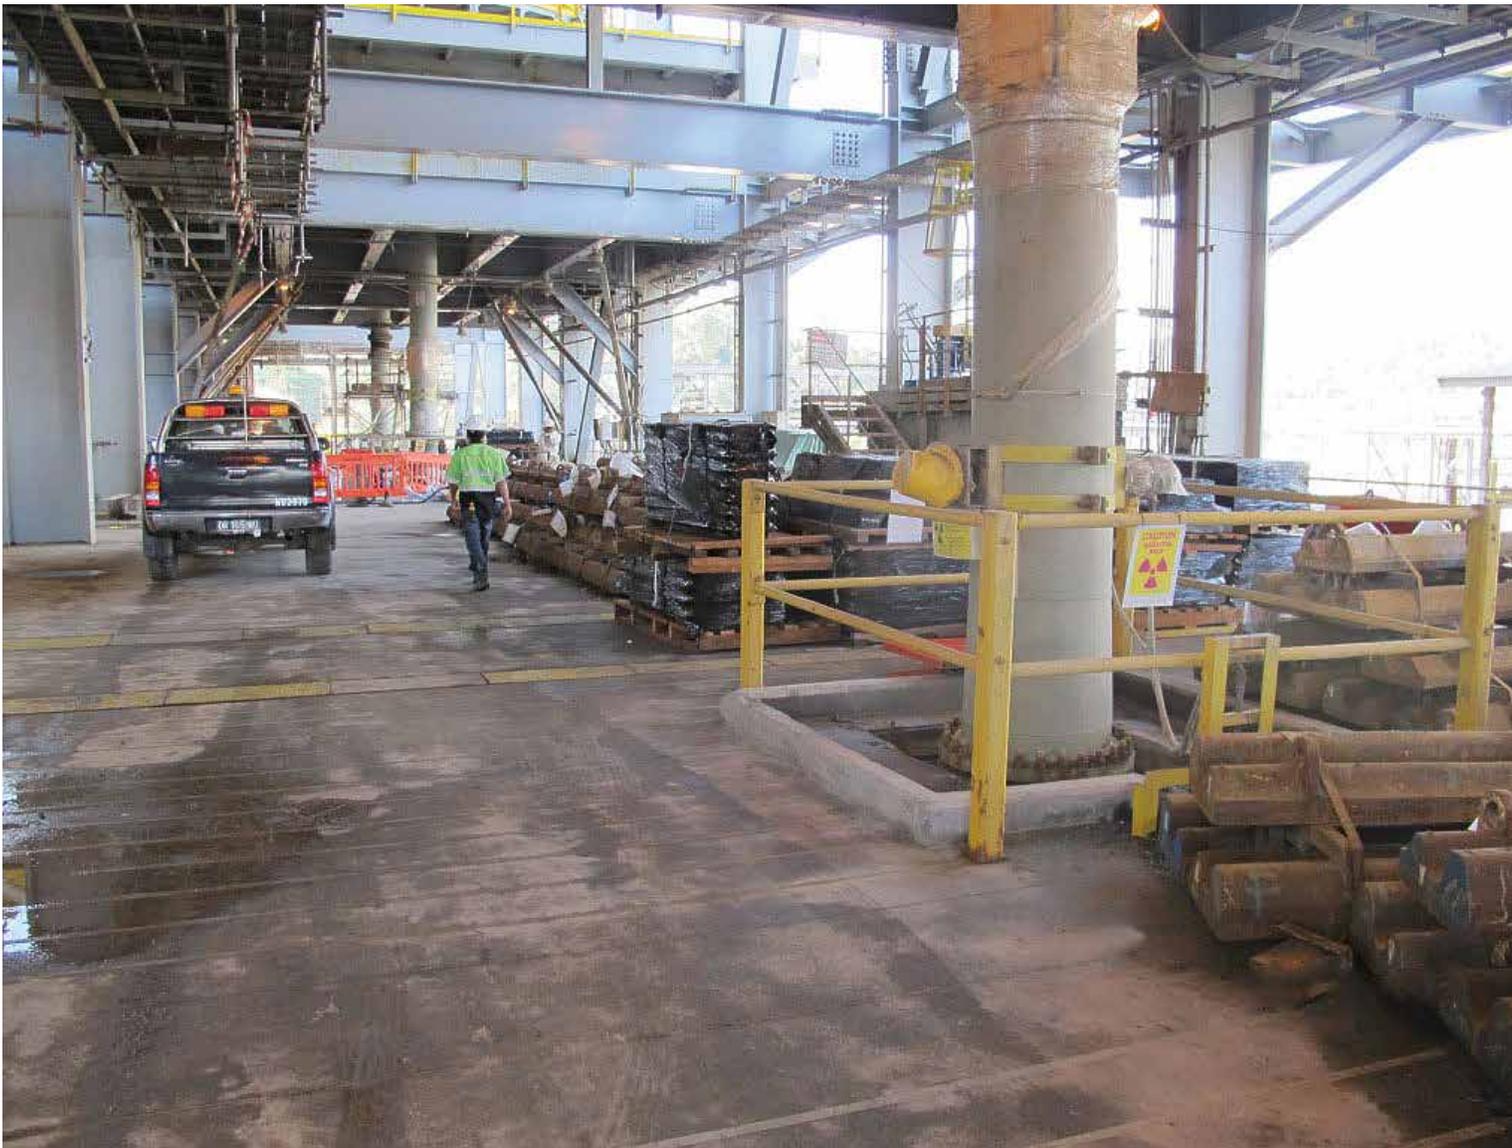
Heavy Steel Mill Liners in Place on Strengthened Floor
