University of Missouri Hospitals and Clinics

Structural Repair and Protection of Post-tensioned Parking Garage

University of Missouri Project

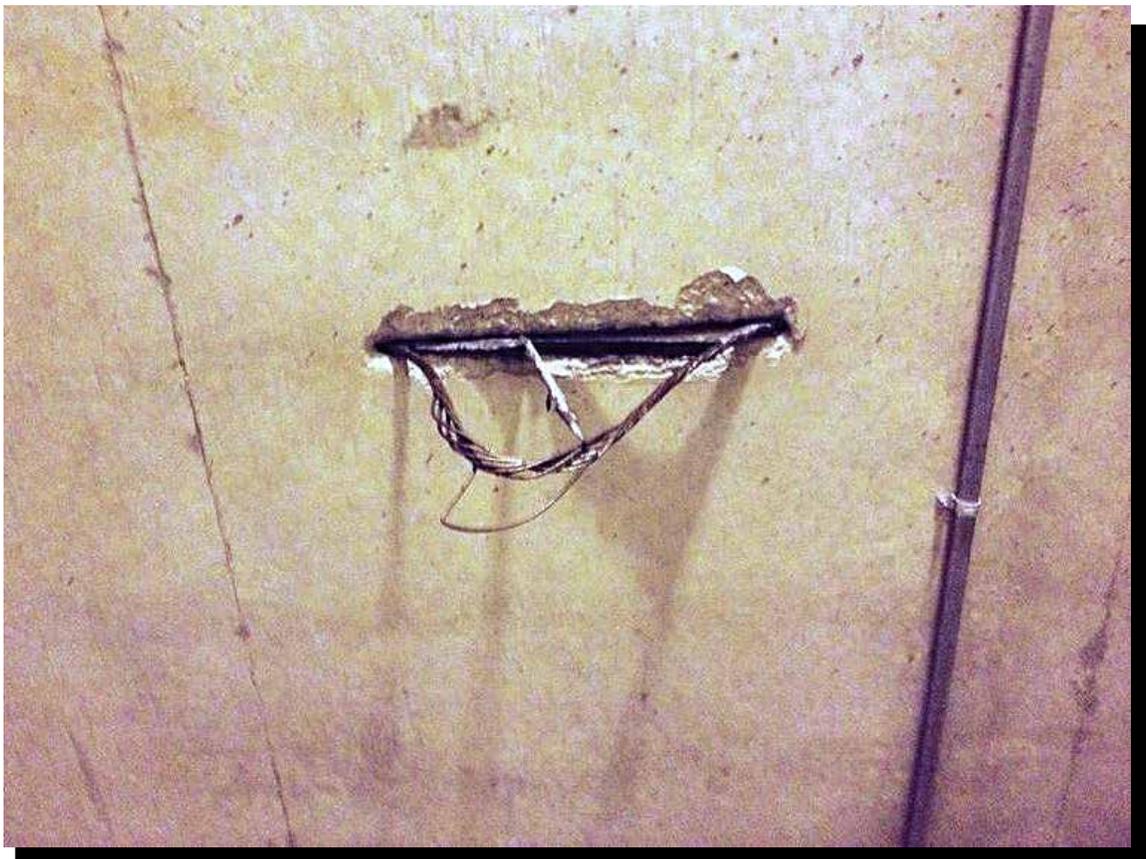
Understanding the vital role of the structure to the University and the community, MUHC staff was immediately concerned upon discovering a broken post-tension tendon protruding from the underside of an elevated deck. MUHC promptly retained a structural engineering firm to investigate the exposed tendon, determine the cause of the failure, and develop a long-term repairs strategy.

Figure 1: Erupted Post-tensioned Tendon Discovered March, 2013

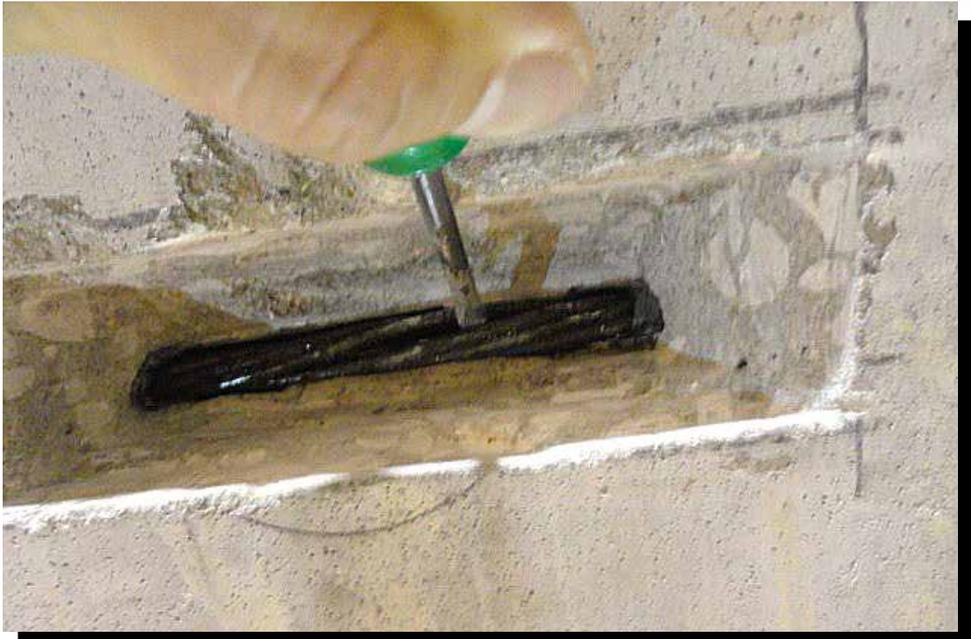
Investigation: The initial investigation occurred at the location of the original tendon eruption (Level 1 North Bay) and included invasive inspections for further tendon breaks, live anchor condition at the expansion joint, and screwdriver penetration tests at mid-span. The penetration test involves wedging a flathead screwdriver between the individual wires which make up the strand. Screwdriver penetration can only be achieved if one or more wires are broken.

Figure 2: Screwdriver Penetration Test Detecting Broken Wires

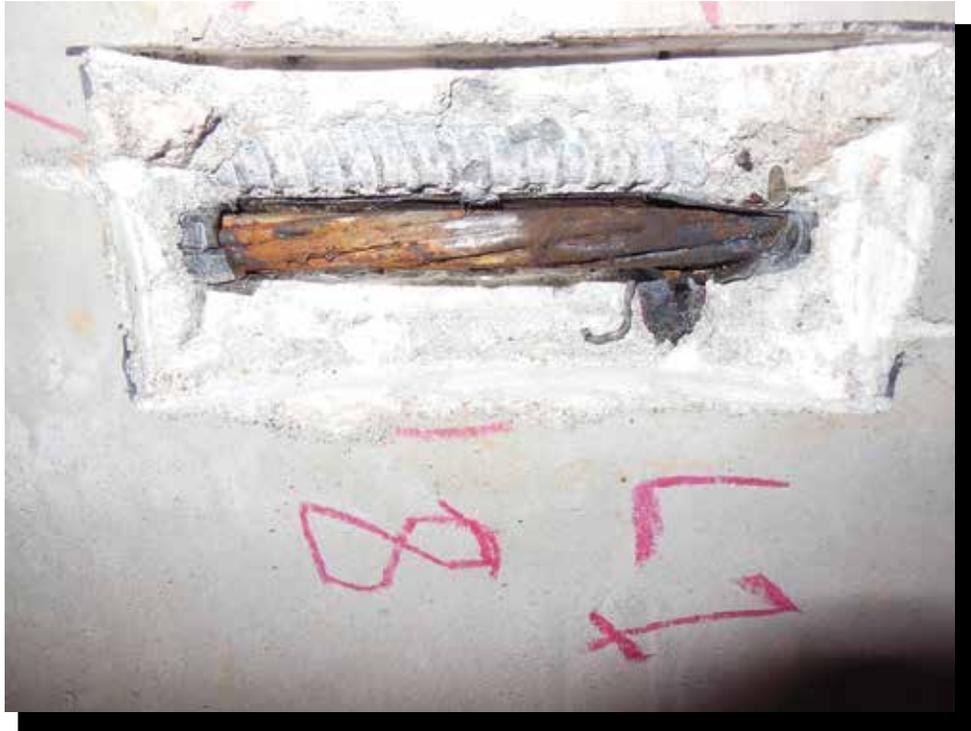
Figure 3: Severe Corrosion and Degraded Grease

Understanding the severity of the corrosion problem, the Engineer identified the cause of the advanced degradation. A gutter system had been installed below the leaking expansion joints. This gutter system trapped debris, moisture, and chlorides from deicing compounds beneath the failed joints, established a corrosive environment at the post-tensioning anchors, and was an entry point for moisture into the tendons. Maintaining the long-term serviceability of the MUHC garage would require both repairing existing structural problems (which would worsen over time) and addressing the corrosion problem that was causing the deterioration.

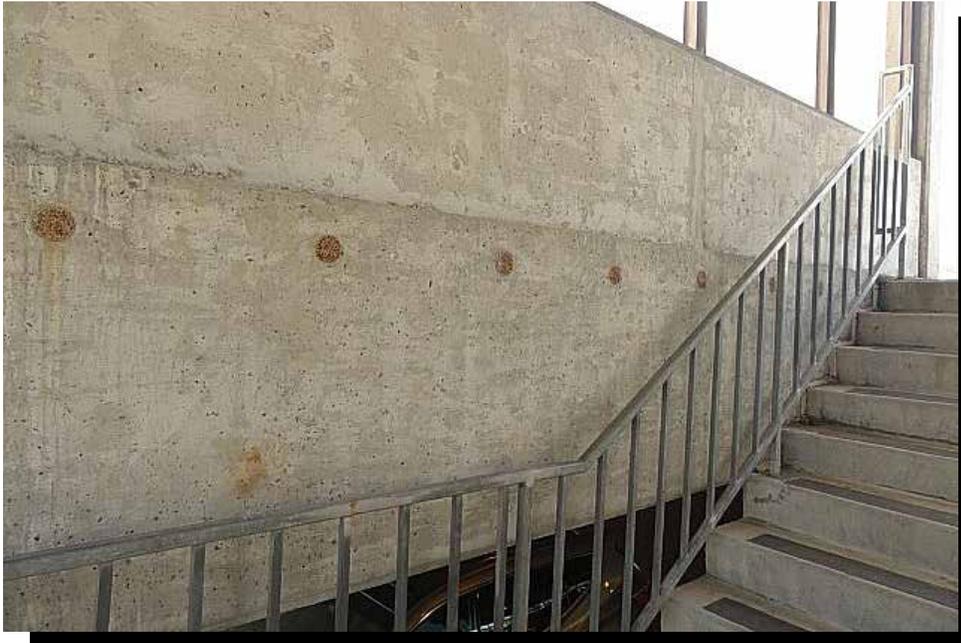
Figure 4: Corrosion at Slab Grout Pockets

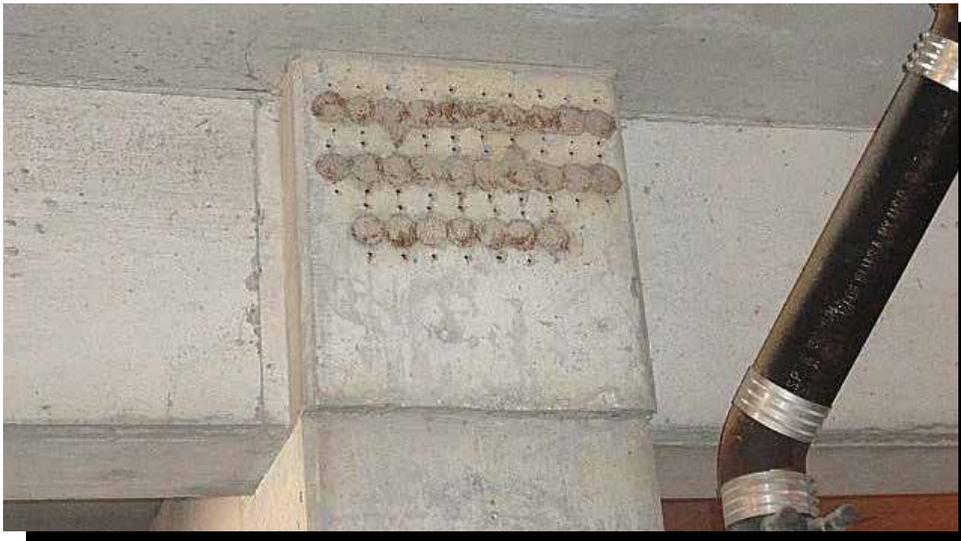
Figure 5: Corrosion at Beam End Grout Pockets

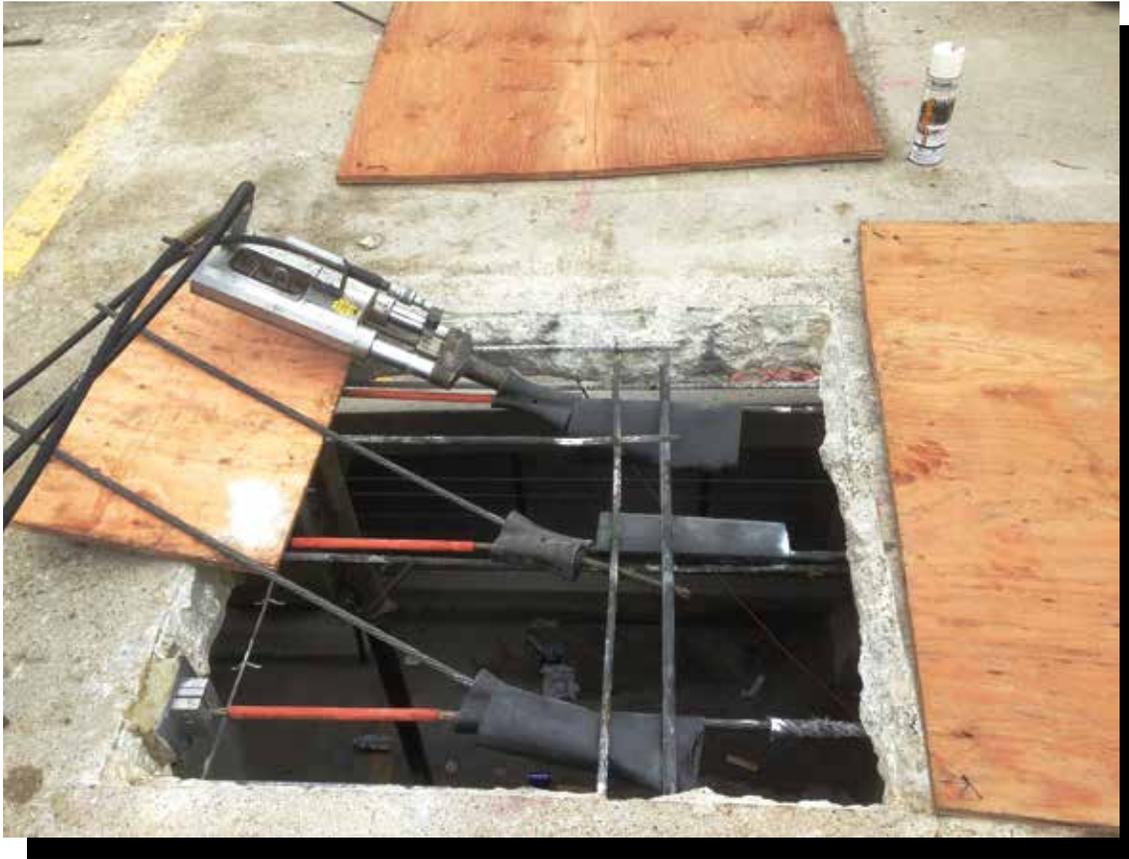
Figure 7: Post-tension Splicing with Center Stressing Chuck

The post-tension repair method was to "lock-off" the tendon lengths that did not require repair and maintain the structural capacity of the level still tensioned while the end anchors were replaced. This method limited the required shoring which in turn kept valuable areas of the garage open for other repairs to be performed simultaneously.

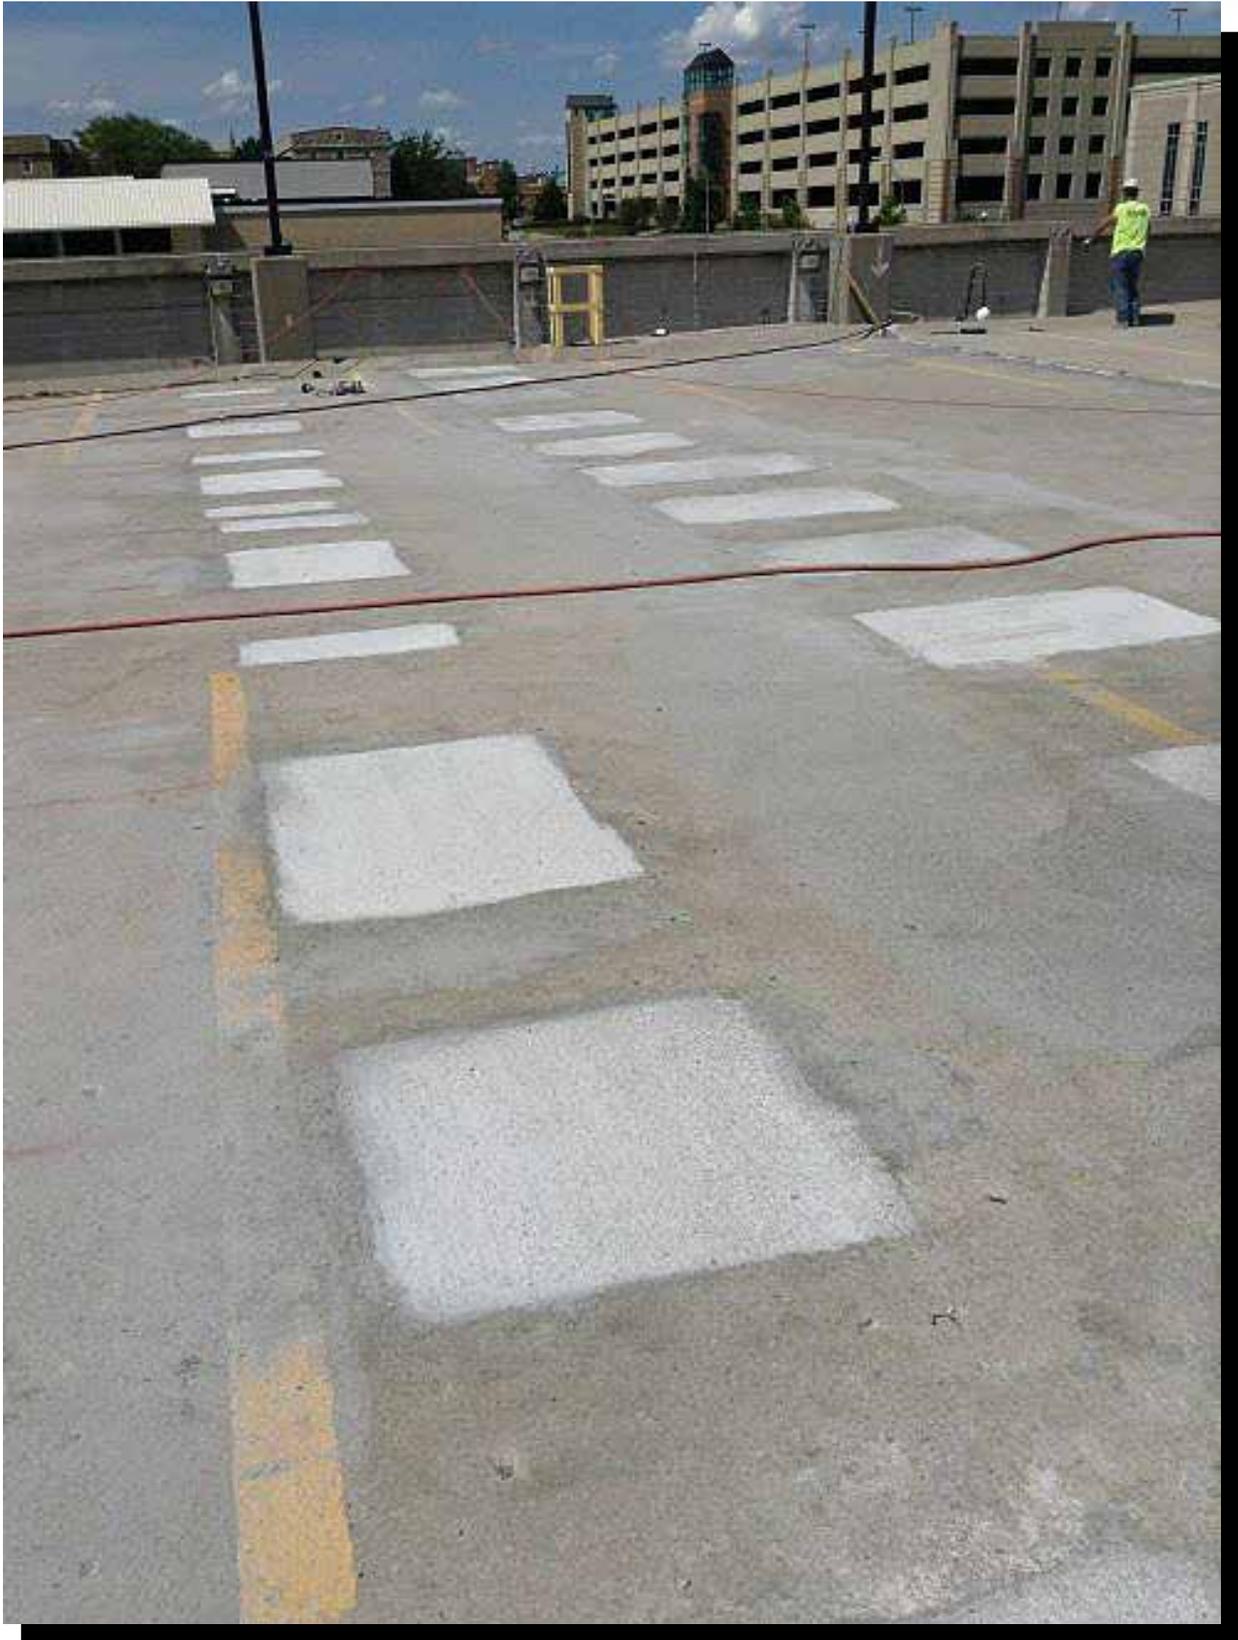
Figure 8: Completed Post-tensioned Slab Repairs

The primary focus of the structural repairs was to re-establish the integrity of the elevated post-tensioned slabs. The immediate task would be to replace 206 live stressing anchorages at the 4 failed expansion joints. The existing live anchorages would be replaced by new, fully encapsulated anchorages. This replacement would require installing various lengths of new tendon as well. Secondly, 29 tendon breaks throughout the garage also required location, splicing, and re-stressing. To round out the complete structural repair, all columns, walls, beams, and overhead concrete delaminations would be repaired by ICRI standards.

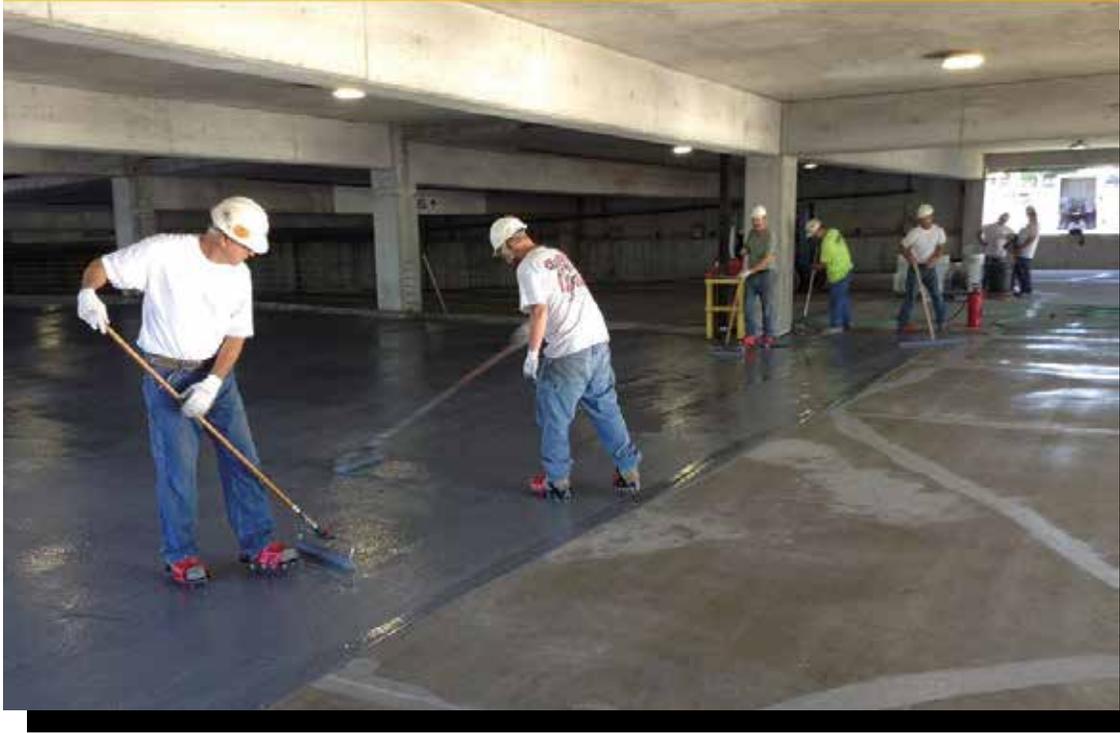
Figure 9: Application of Waterproofing Membranes

Once the problem of deterioration was addressed, the cause of those problems would have to be eliminated to ensure an extended service life for the structure. The failed expansion joints and gutter systems on each level were removed and replaced with watertight elastomeric wing compression type expansion joints. Following the replacement of the joints, a heavy duty vehicular traffic waterproofing membrane to protect the repaired slabs from further moisture and chloride intrusion was installed. This protection included a pedestrian membrane in stairs, a slab-on-grade deck coating, and re-striping to conform to current ADA standards.

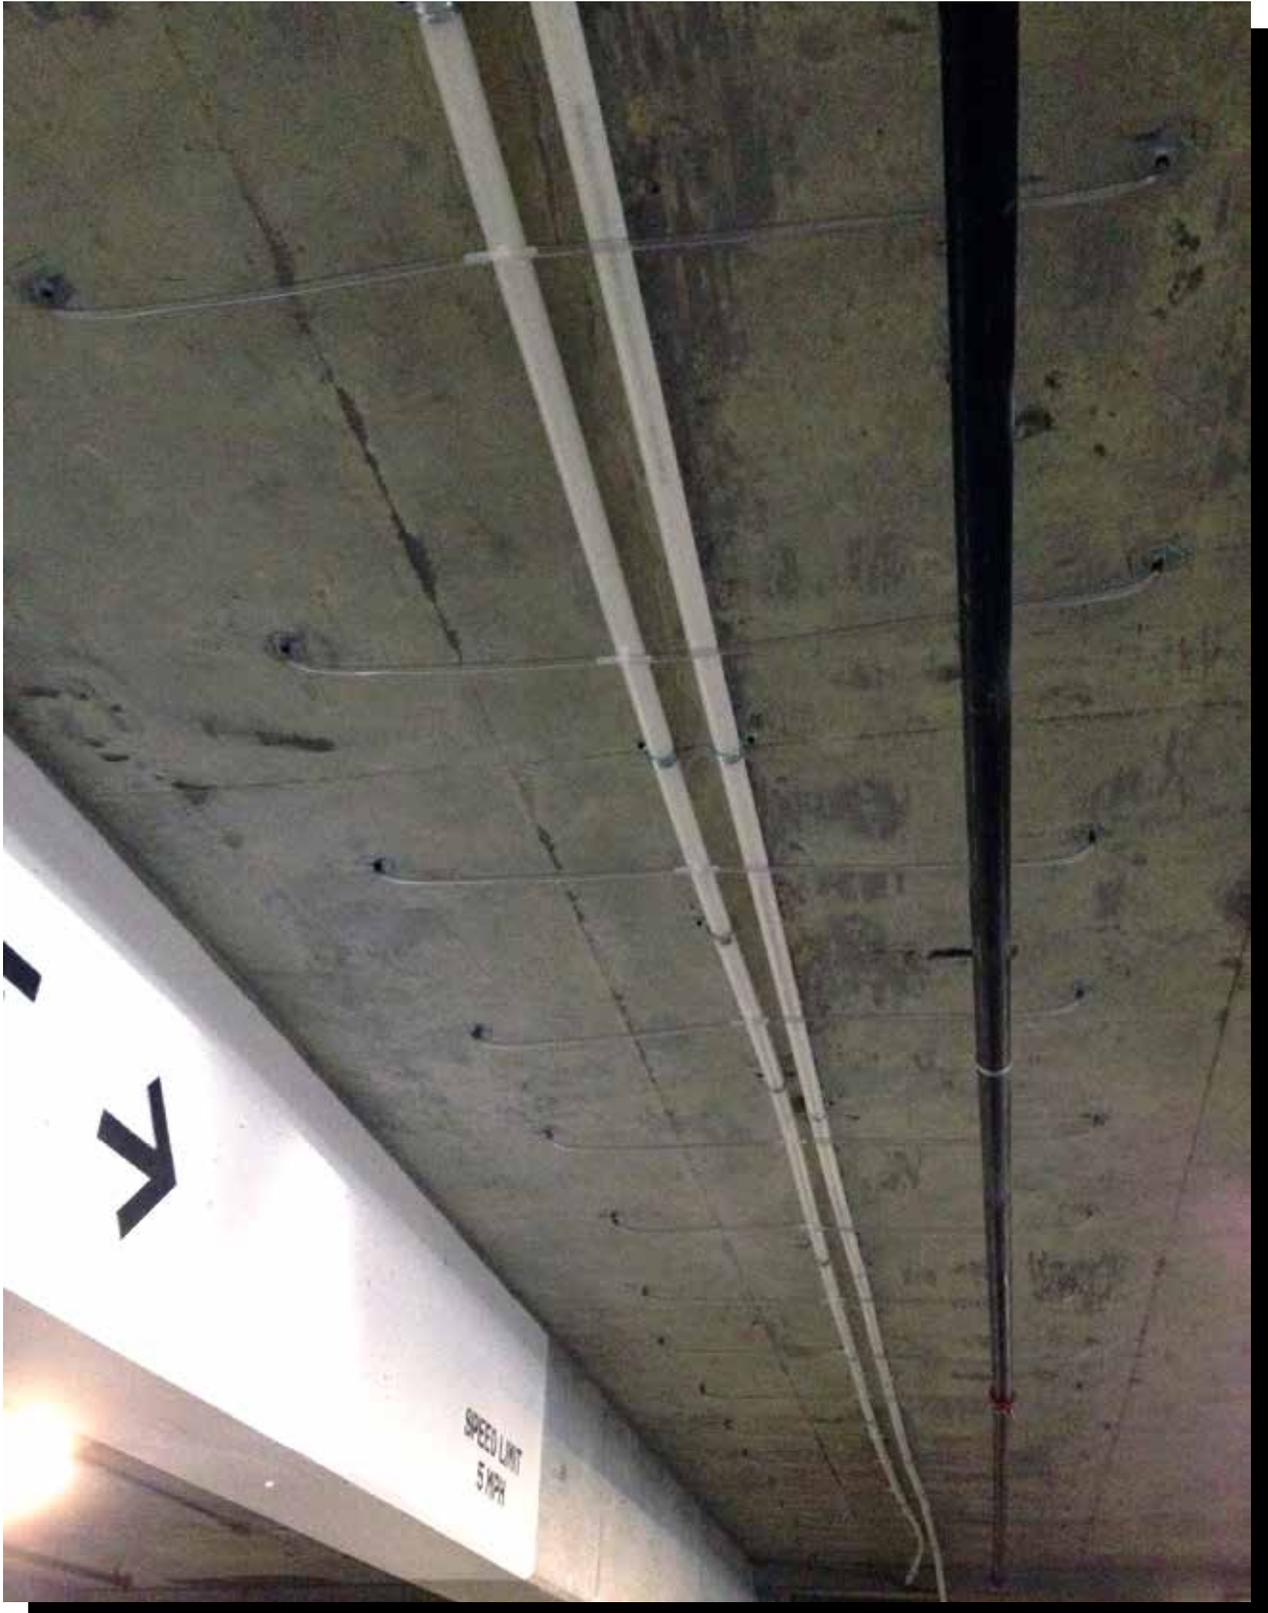
Figure 10: Manifold System and Input Air Ports for PT Cable Drying

On each of the 421 tendons to be dried, input and exit ports are installed using custom designed shut-off drills such that the post-tensioned strand would not be inadvertently damaged. Then manufactured dry air is transported to each tendon through temporary piping and passed through the tendon under controlled flow and pressure. The exhaust is monitored at the exit port until it has been determined that all bulk water and moisture from the grease and the interior spaces of the 7-wire stand has been reduced to sufficient levels.

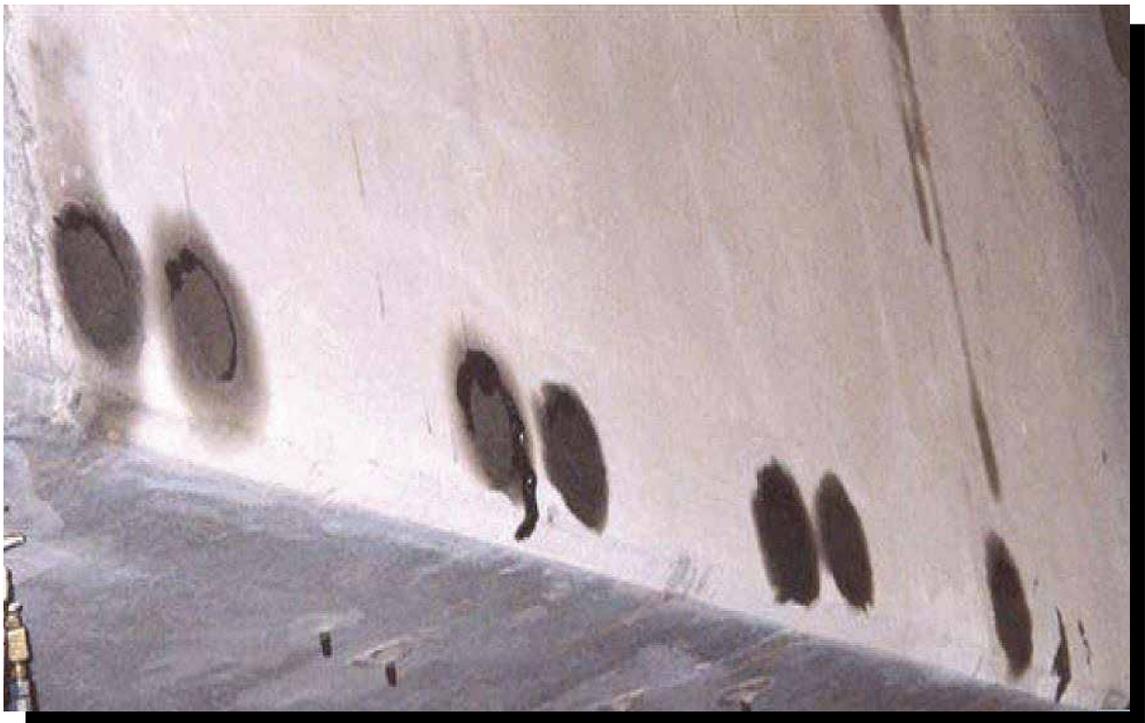
Figure 12: Post-tension Re-Greasing at Grout Pockets

After the post-tensioned cable drying process was completed, new anti-corrosion grease was placed in the individual tendons to eliminate any existing voids and to improve the corrosion resistance of the post-tension system.

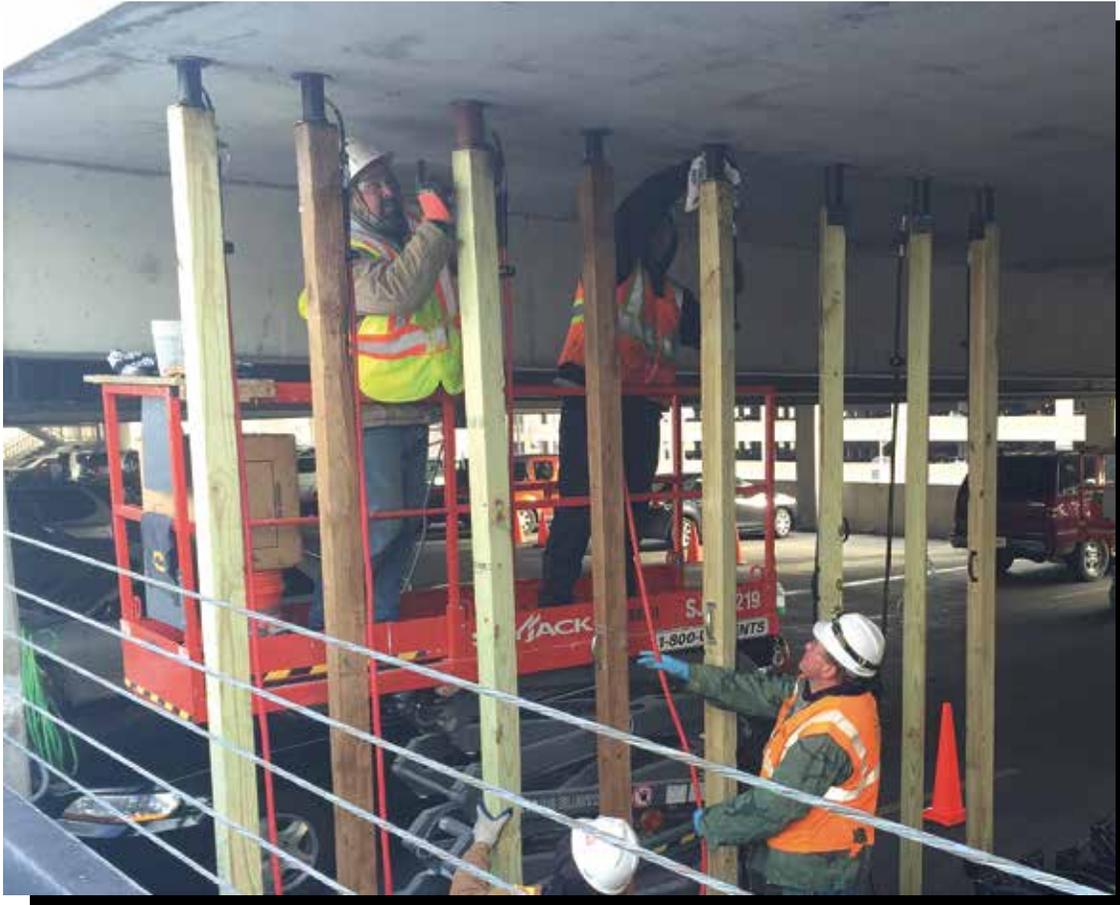
Figure 13: Post-tension Grease Injection Operation
