## IMC Potash, Esterhazy MCC Room Roof Repairs

STRUCTURE: Electrical MCC Room  
 LOCATION: K-2 Minesite, Esterhazy  
 PROJECT DATE: 2002 & 2003  
 JOB DURATION: 4 Weeks per Year  
 CLIENT CONTACT: Terry Heal  
 CONTRACT AREA: 6,000 ft<sup>2</sup>  
 CONTRACTOR: Vector Construction Ltd.  
 Saskatchewan Branch

#15-02SK\_IMC Esterhazy

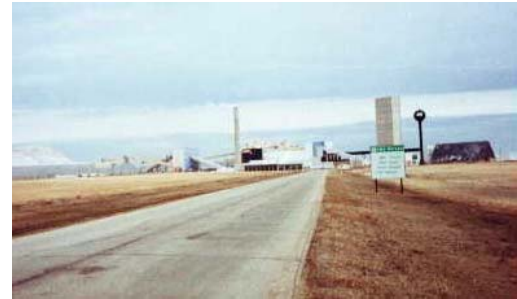
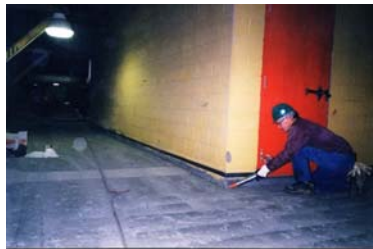
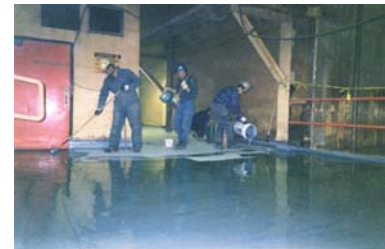
Problem: Wash-down water leaking through the roof & dripping down onto electrical control equipment.

Recommended Repair System: Qualipur Traffic Bearing Polyurethane Membrane System.

- Procedure:
- Remove existing deteriorated membrane system, originally installed 18 years ago.
  - Patch and repair concrete substrate as required.
  - Rout and seal all cracks and expansion joints using Sonneborn NP1.
  - Properly prepare and install Qualipur traffic bearing membrane, seed the top coat to saturation with Unimin Round Sand of proper gradation.
