Disraeli Bridges Project

Concrete Repair and Corrosion Mitigation of Concrete Piers

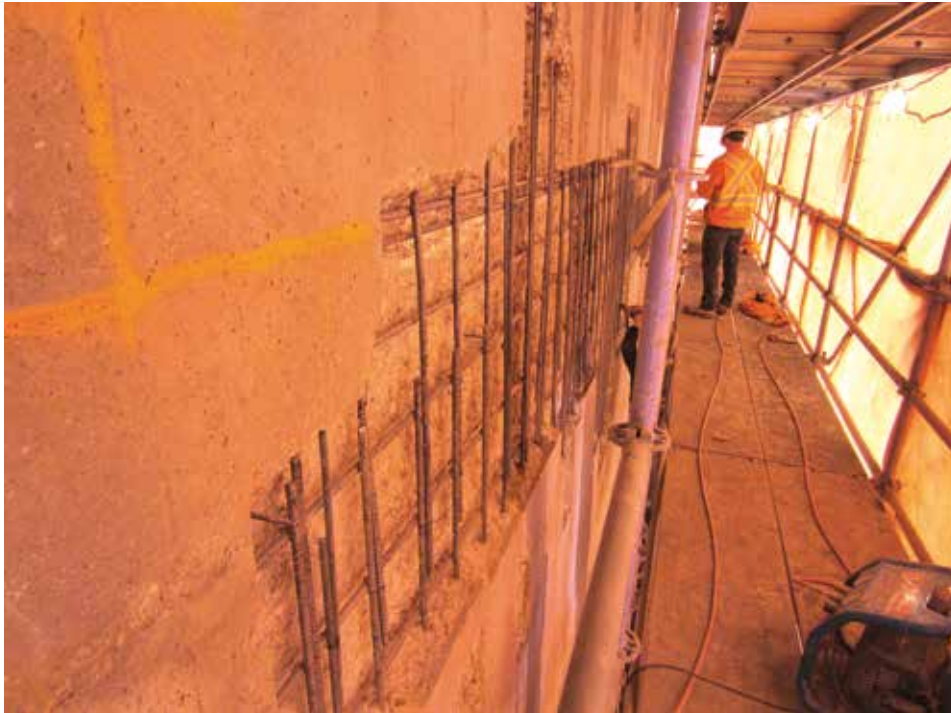
Example of Corrosion Damage on Red River Bridge Piers

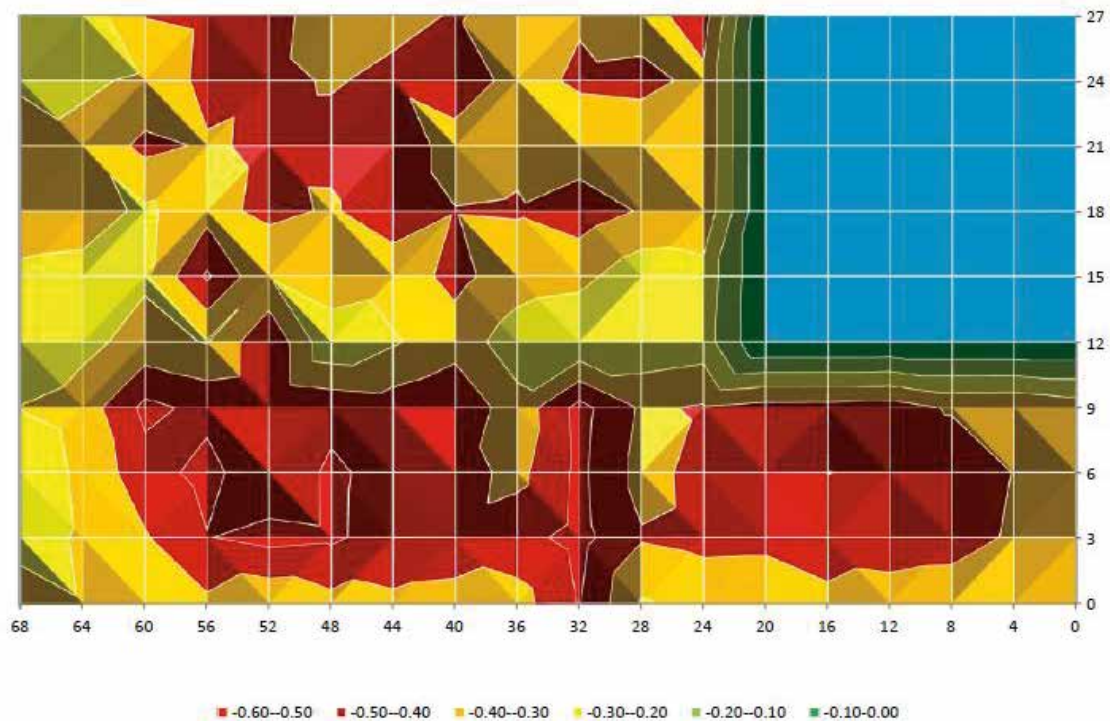
Half Cell Corrosion Potential Map of Bridge Pier Indicating Locations with a High Probability of Active Corrosion

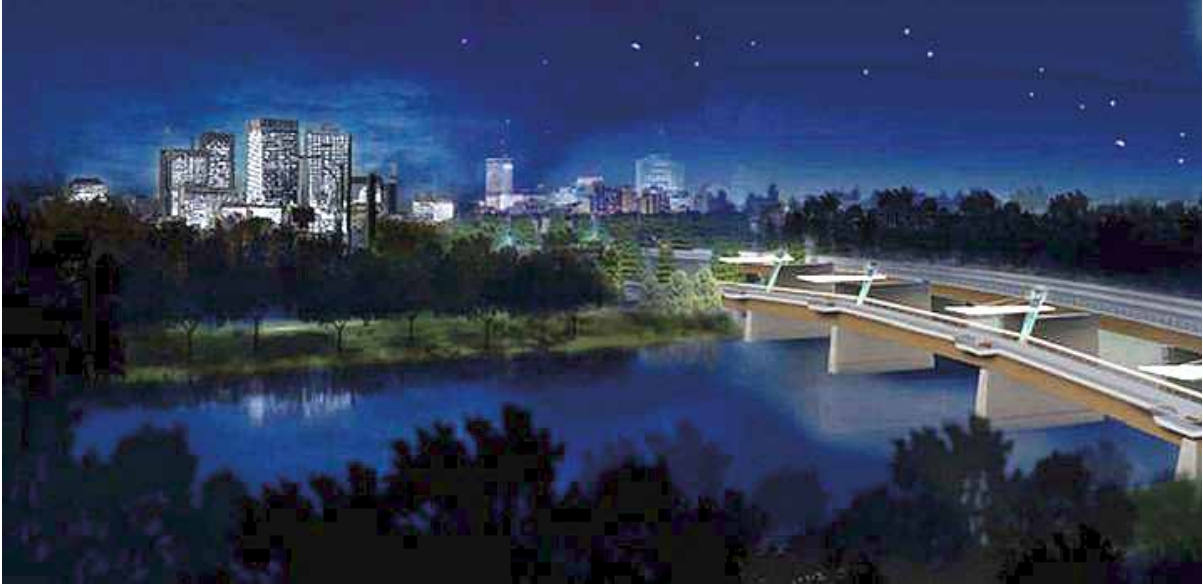
Conceptual Drawing of the Red River Bridges – the Existing Bridge Piers were Rehabilitated and used to Support the Pedestrian Bridge

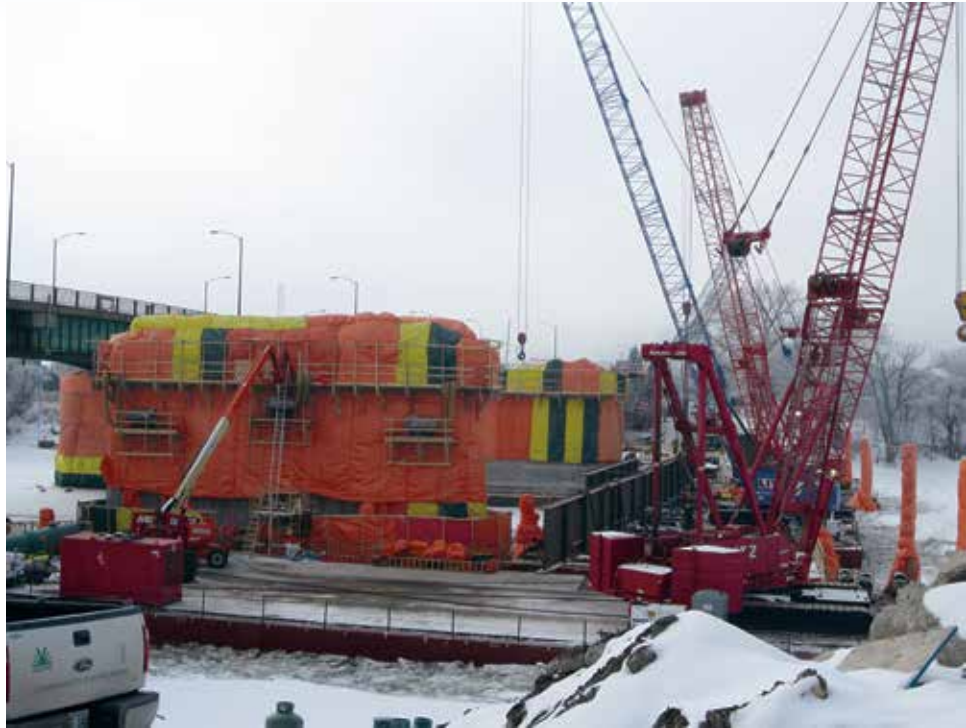
*Repair and Corrosion Mitigation of Piers
Proceeded inside Heated Enclosures*

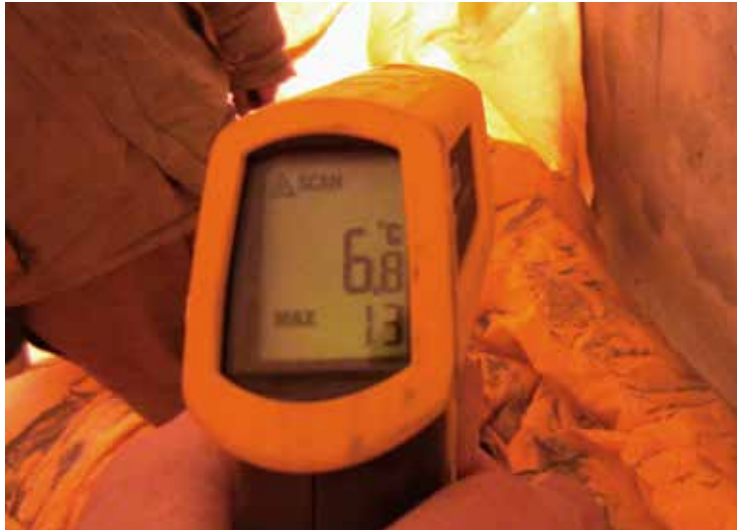
The Heated Enclosure Allowed Work to Proceed Despite Exterior Temperatures as Low as -30°C

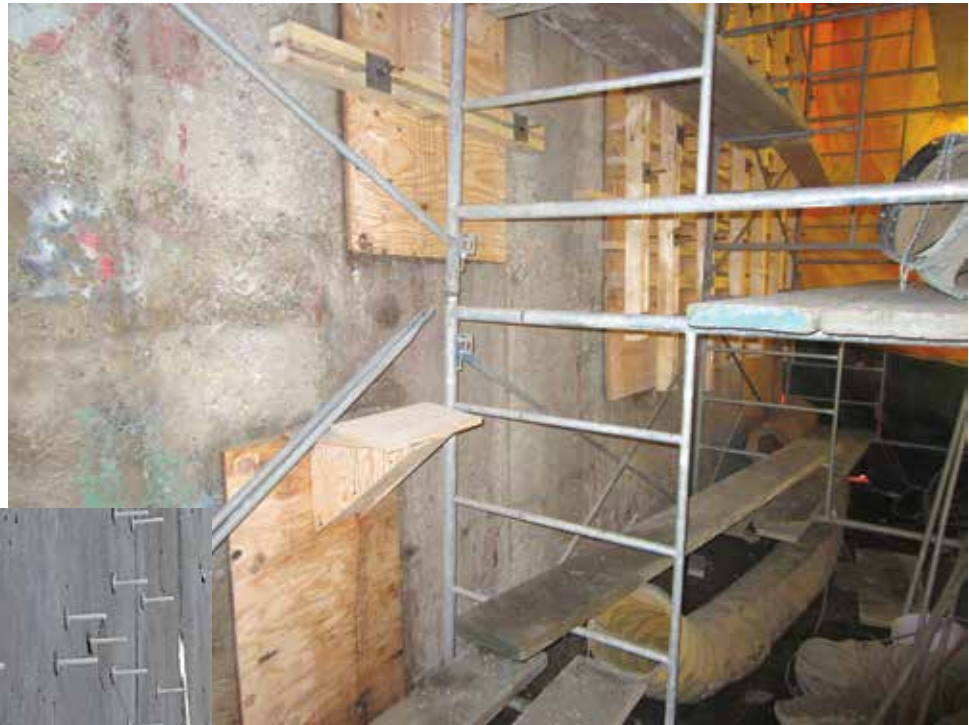
Plywood Formwork in Place

After the damaged concrete was removed, the repairs were sandblasted to remove any loose material and create a rough but sound surface for mechanical bond of the repair material. The repair areas were formed using plywood to match the existing pier profile. Prior to placing the flowable concrete, the substrate was maintained in a saturated surface-dry condition, then concrete was placed using a concrete pump. The forms remained in place for 7 days and then a curing compound was applied after form removal. A total of 197m² (2,120 ft²) of structural concrete repairs were completed from January to March of 2012. Structural cracks in the piers, potential areas of vulnerability for future chloride-ingress, were epoxy injected using low viscosity resin and a plural component pump.

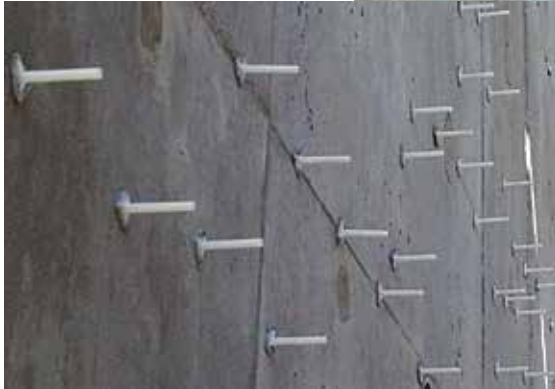
Ports in Place for Epoxy Injection Crack Repair

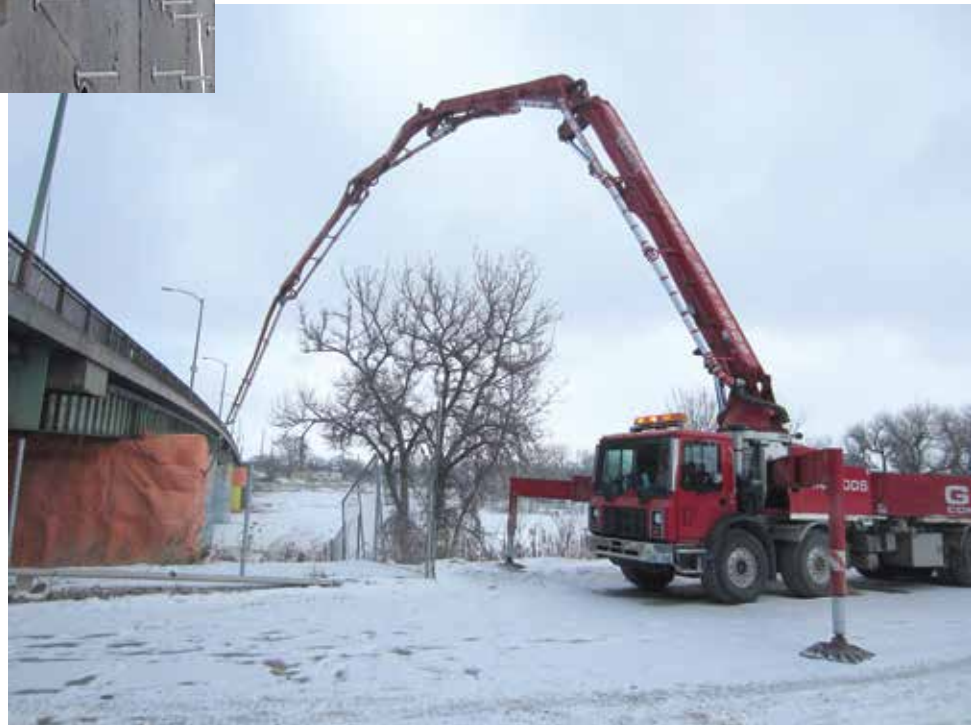
Pump Truck Delivering Concrete for the Repairs

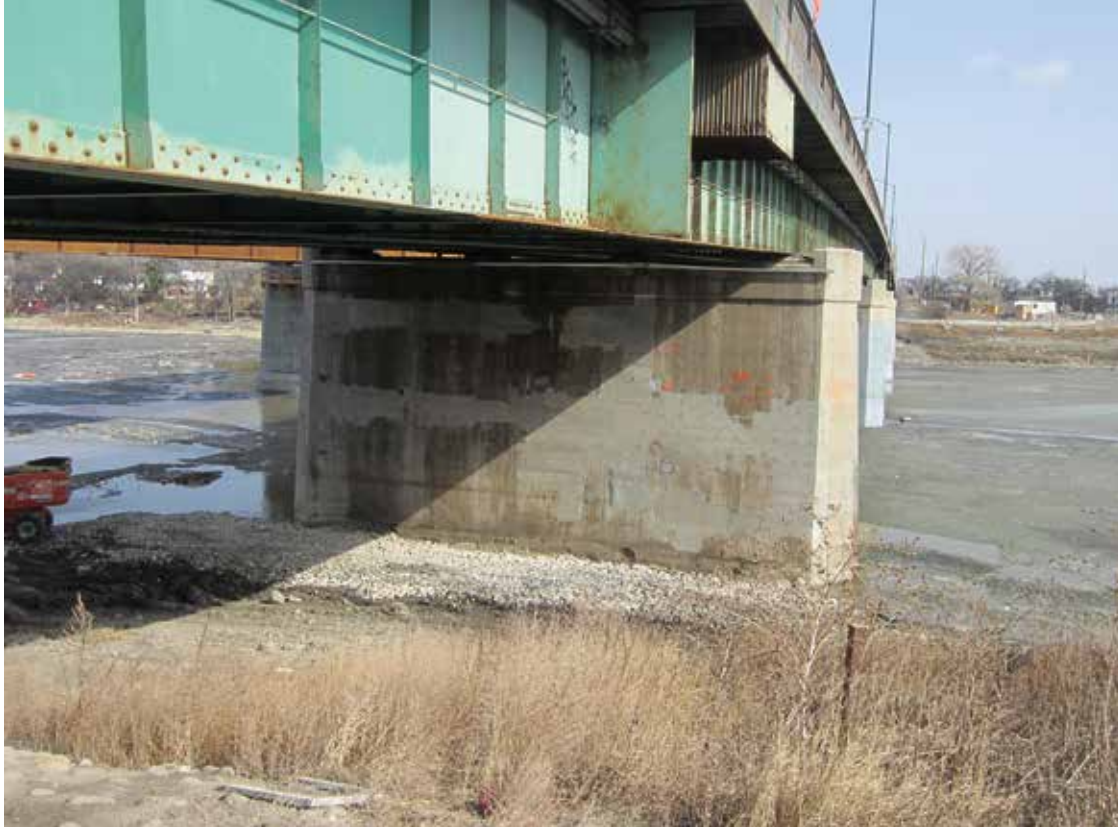
Completed Concrete Repair of Red River Bridge Pier

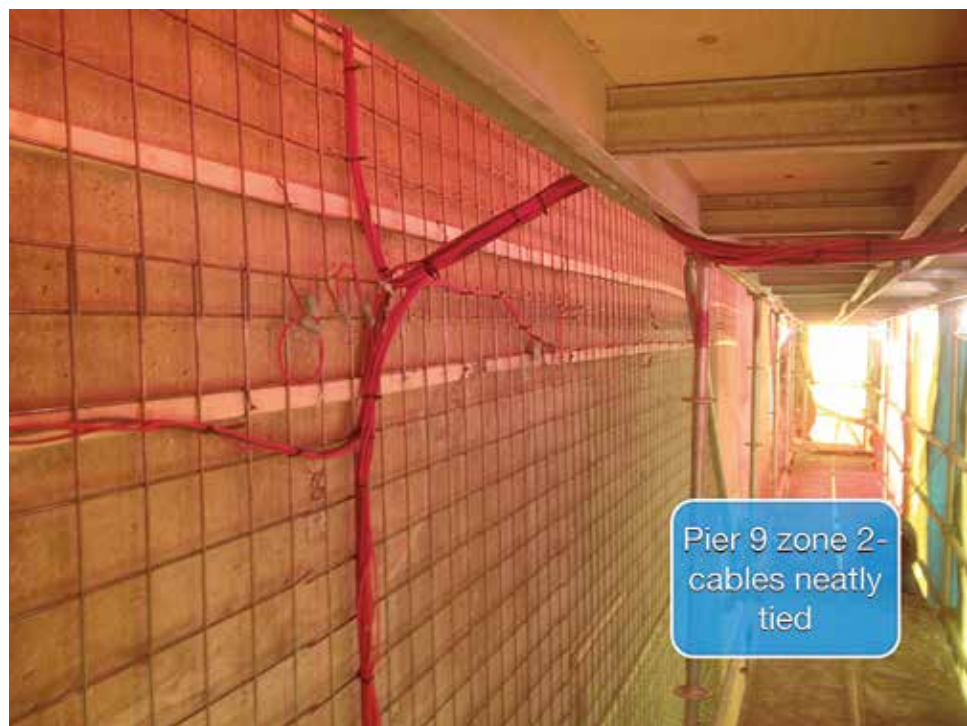
Temporary Anode Mesh and Wiring in Place for Electrochemical Chloride Extraction Treatment for the Two Land-Based Piers

A temporary DC electric field is created by transformer-rectifier connected between the reinforcing steel and an external electrode mesh embedded in a mixture of potable water and cellulose fiber. During the treatment, the anode mesh is continuously wetted by an irrigation system and water runoff is collected. The applied electric field causes the negatively charged chloride ions to move from the reinforcing toward the positively charged external electrode mesh. Once the chloride content has been

reduced to acceptable levels, and the pH of the concrete surrounding the reinforcing steel has been raised, the temporary anode and electrolyte media is removed.

A total area of 637m² (6,860 ft²) was treated by the ECE process between November, 2012 and March, 2013. Because of the project schedule constraints, the ECE treatment duration lasted as long as possible with all equipment and materials removed prior to the spring thaw. Each zone was energized for 41 days, achieved an average current of 1508 A-hrs/m², and chlorides at the level of the steel were reduced by 68 to 88%.

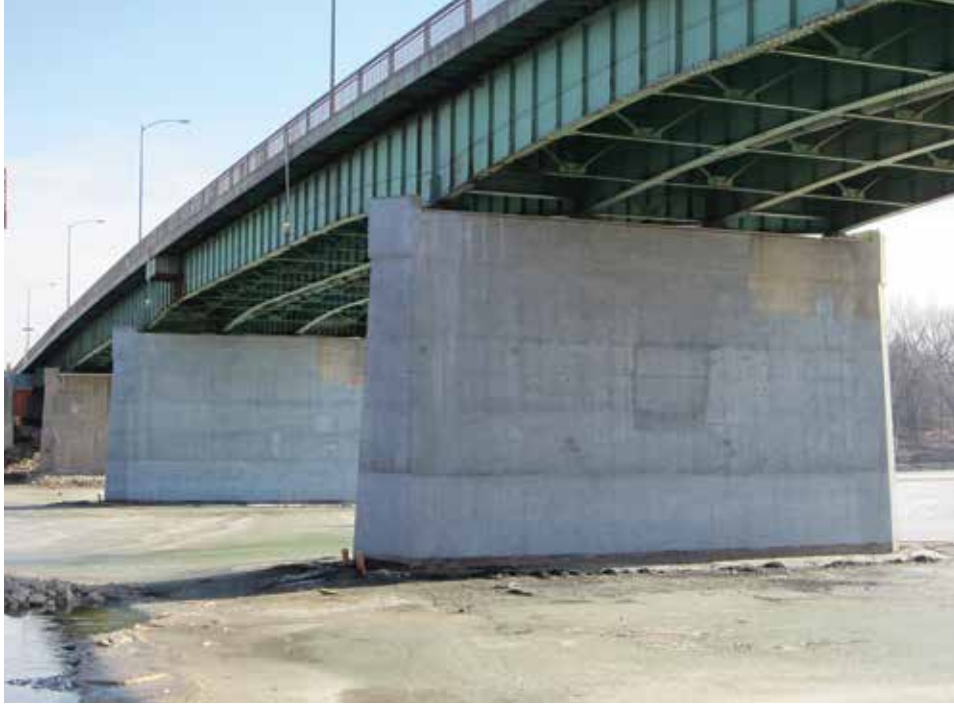
Humectant Activated Arc Sprayed Zinc was used to Protect the Two Interior Piers

From January to February of 2012, a humectant activated arc spray zinc system was installed under the supervision of a Cathodic Protection Technician certified by the National Association of Corrosion Engineers to protect a total area of 873m² (9,392 ft²). High purity zinc was applied onto the prepared concrete surface at a thickness of 500µm (20 mils). Connection to the reinforcing steel was made using flattened expanded zinc mesh plates bolted to the surface over threaded rebar connections with galvanized nuts and washers. After zinc application, the humectant activator solution was sprayed on the surface of the zinc anode at rate of 100mL/m² (0.0026 gal/ft²).

Quality control procedures included verification testing of anode thickness and bond strength. The thickness was confirmed by coupon testing every 6m² (64 ft²) of anode surface. The bond of the anode to the concrete was tested using the direct tension method every 92m² (1,000 ft²) to verify that the bond strength exceeded 1 MPa (145 psi).
