Parrish & Heimbecker Hamblin Grain Silo Terminal

STRUCTURE: Grain Storage Silo
 LOCATION: Hamblin, SK
 PROJECT DATE: 1994
 JOB DURATION: 6 weeks
 CLIENT CONTACT: Bill Parrish
 CONTRACTOR: Vector Construction Ltd.
 Saskatchewan Branch

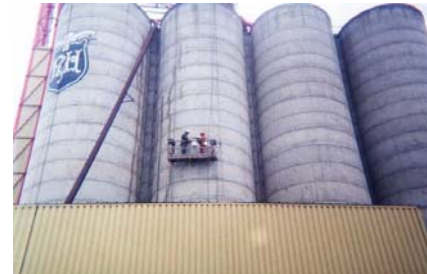
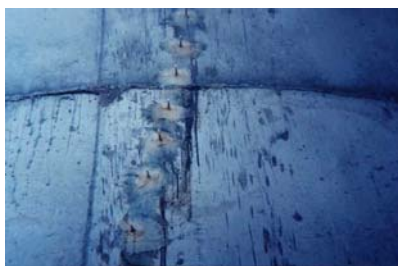
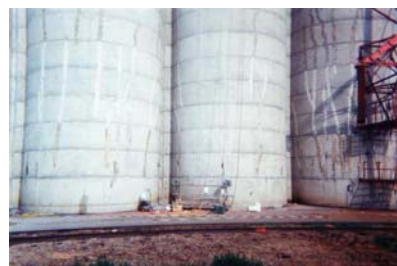
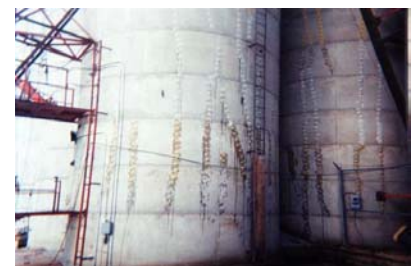
- Problem:** Structural cracking of the silo structures caused by improper loading and off loading of the structure. The cracks also allowed moisture to penetrate the walls and spoil the stored grain.
- Area:** 5660 lineal ft. of crack injected all in the exterior exposed walls of 10 towers joined together by star bins to form a single structure.
- Procedure:**
- i) Install access to exterior walls using swing stage and/or JLG lift.
 - ii) Lay-out and identify the cracks that were to be injected.
 - iii) Install ports and surface seal with Concessive 1422.
 - iv) Inject Concessive 1360 epoxy resin using the patented SCB injection process and products.
