University of Missouri Hospitals and Clinics

Structural Repair and Protection of Post-tensioned Parking Garage

University of Missouri Project

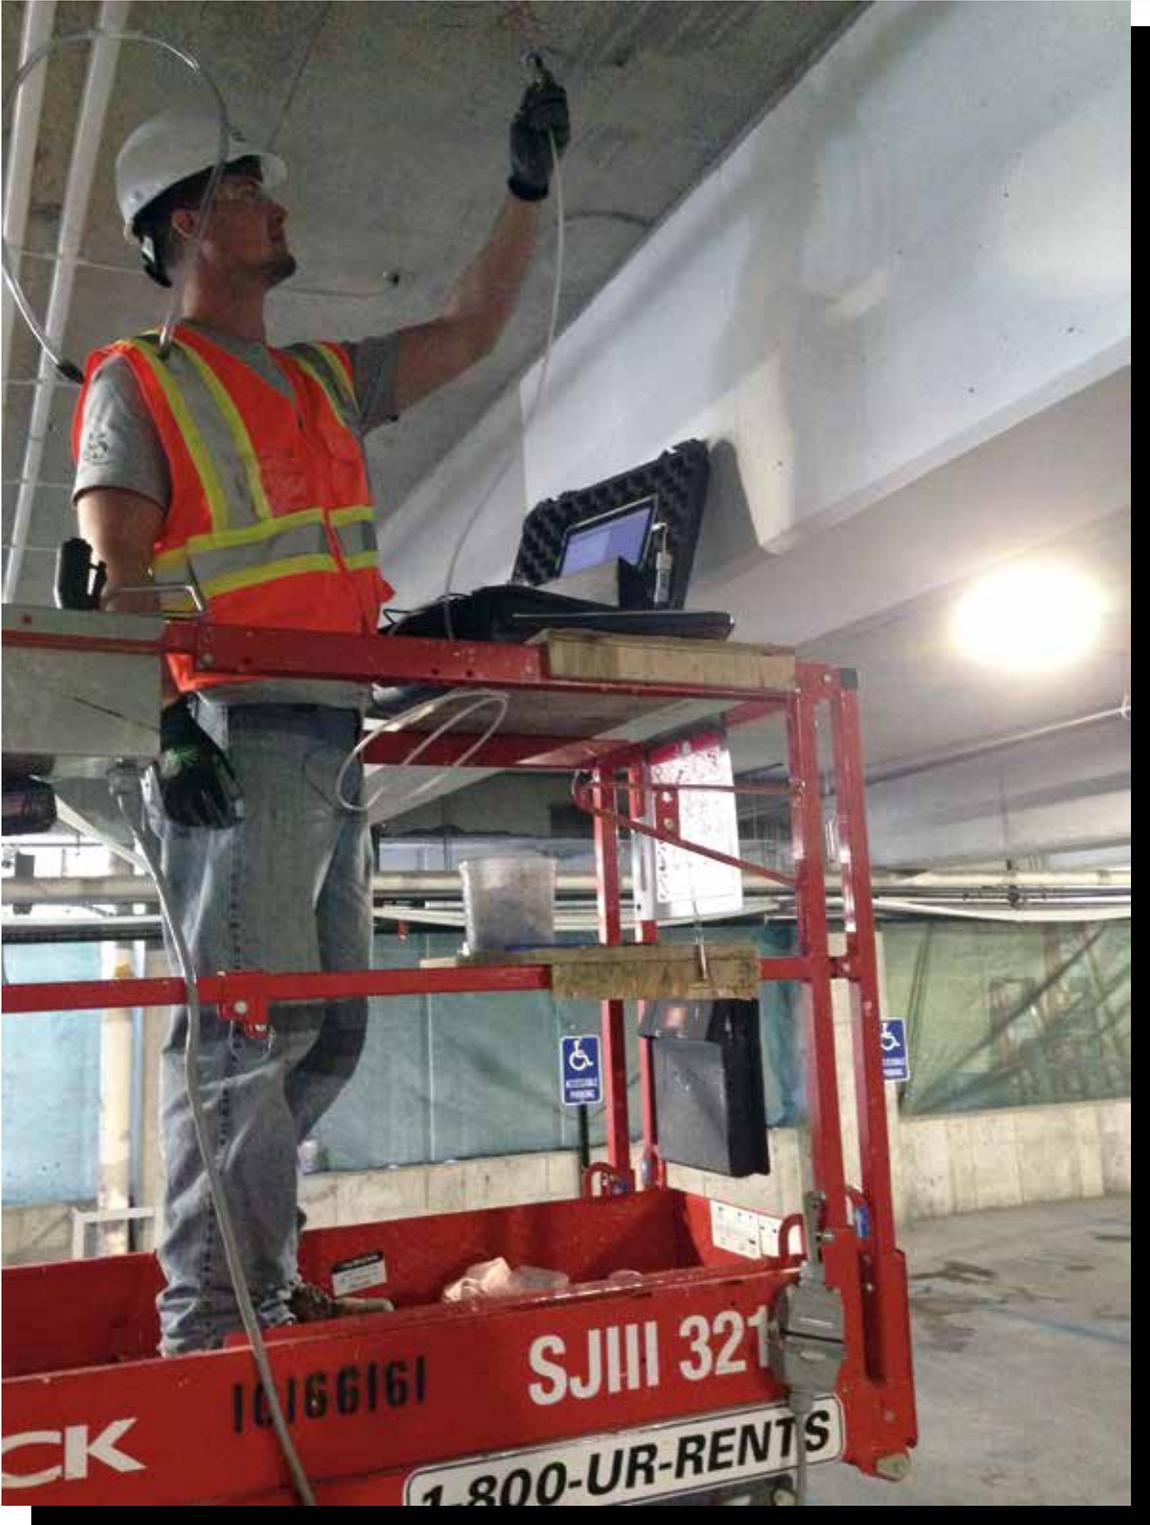
Figure 6: Post-Tensioned Slab Corrosion Evaluation Procedure (moisture test)

Results: A total of 27 out of 497 tendons that were exposed had broken or missing strands at the test locations. 65% of tendons were determined to be in good to fair condition. However, 62% had missing or degraded grease and 98% had excessive moisture levels.
