Kelsey Generating Station Spillway Rollway Grouting and Deck Repairs

STRUCTURE:	Kelsey Generating Station Spillway and Powerhouse
LOCATION:	Kelsey, Manitoba
PROJECT DATE:	1984 & 1985
JOB DURATION:	2 Years
CONTRACT AMOUNT:	\$ 775,000
CLIENT:	Manitoba Hydro
CONTRACTOR:	Vector Construction Group

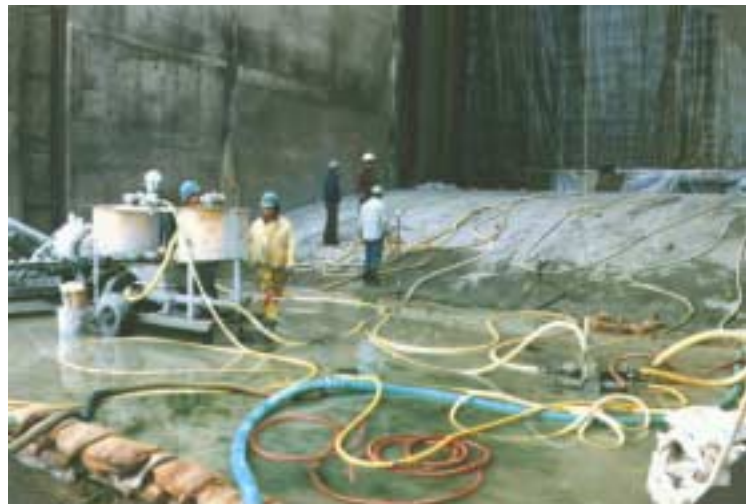
Due to poor concrete consolidation during the original construction there were voids in the concrete of the Spillway Rollways. To complicate matters, water was leaking through the concrete, causing further deterioration. In another area, on the Powerhouse deck, the concrete had deteriorated from freeze-thaw action which had been accelerated by de-icing salts.

To fill the void in the Spillway Rollways cementitious grouting was chosen. Holes were drilled on a grid pattern through the concrete and into the bedrock below. The holes were then watertested to establish the location of the voids and their size. A fluid cement grout was pumped under pressure through the holes, filling the voids and any cracks in the rollway concrete. This provided a solid leakproof rollway.

The Powerhouse deck was repaired by removing the deteriorated concrete and pouring new air-entrained higher strength concrete to replace it. Also, at the same time the leaking expansion joints were replaced with new compressive seal type joints.
